DEPARTMENT OF TRANSPORTATION

Contract #: 04-0120F4Cty: SF/ALA Rte: 80 PM: 13.2/13.9File #: 69.28**WELDING INSPECTION REPORT****Resident Engineer:** Siegenthaler, Peter**Address:** 333 Burma Road**City:** Oakland, CA 94607**Report No:** WIR-019205**Date Inspected:** 03-Dec-2010**Project Name:** SAS Superstructure**OSM Arrival Time:** 700**Prime Contractor:** American Bridge/Fluor Enterprises, a JV**OSM Departure Time:** 1900**Contractor:** Zhenhua Port Machinery Company, Ltd (ZPMC), Changxing Island **Location:** Shanghai, China

Bike Path-DCP

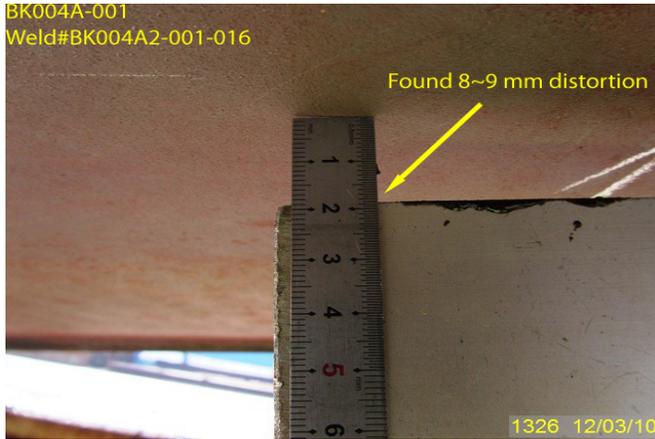
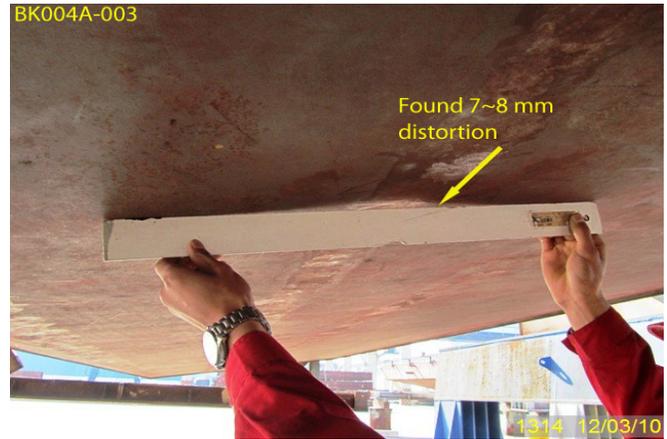
-During random DCP check, this QA inspector observed out of flatness across the weld exceed the allowable tolerance.

-The component is Bike Path bottom cover plate, seam weld.

-The thickness of the bottom plate is 6mm.

-According to the Standard Specification 1999, Section 55, flatness of the splice weld is measured by 600mm straight edge and the allowable tolerance is 5mm.

-Maximum out of flatness was observed as 7 mm on bike path BK004A-001, weld#BK004A2-001-016,
9.5mm on bike path BK004A-003, weld#BK004A2-003-016.
7.5mm on bike path BK004A-003, weld#BK004A2-008-016-full length.
7.5mm on bike path BK004A-003, weld#BK004A2-008-018.
10mm on bike path BK004A-003, weld#BK004A2-010-018.
