DEPARTMENT OF TRANSPORTATION

Contract #: 04-0120F4Cty: SF/ALA Rte: 80 PM: 13.2/13.9File #: 1.28**WELDING INSPECTION REPORT****Resident Engineer:** Siegenthaler, Peter**Address:** 333 Burma Road**City:** Oakland, CA 94607**Report No:** WIR-019218**Date Inspected:** 08-Jan-2011**Project Name:** SAS Superstructure**OSM Arrival Time:** 630**Prime Contractor:** American Bridge/Fluor Enterprises, a JV**OSM Departure Time:** 1500**Contractor:** American Bridge/Fluor Enterprises, a JV**Location:** Job Site

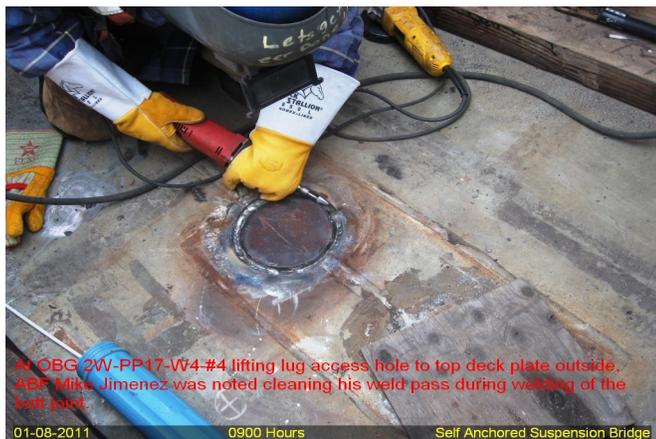
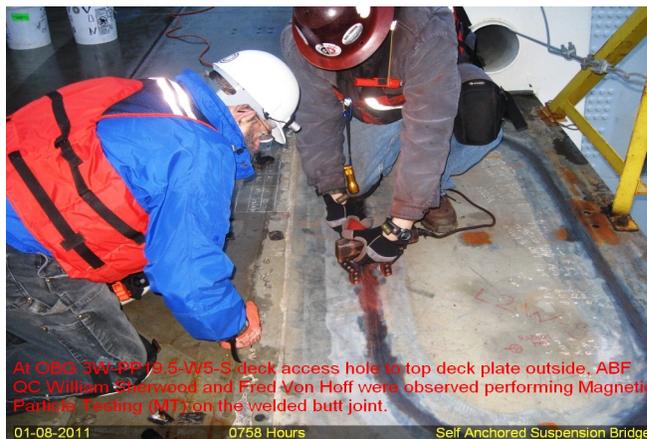
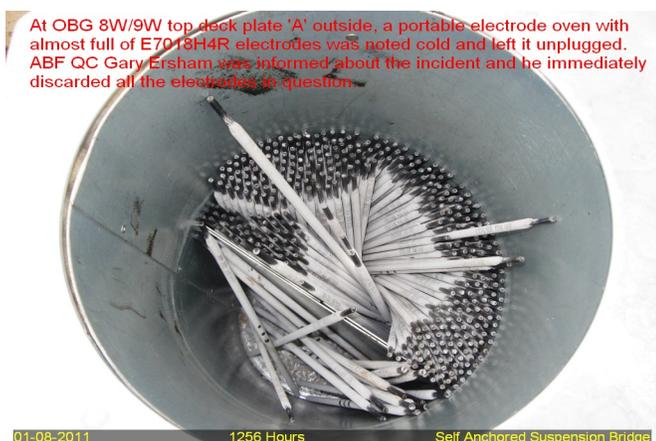
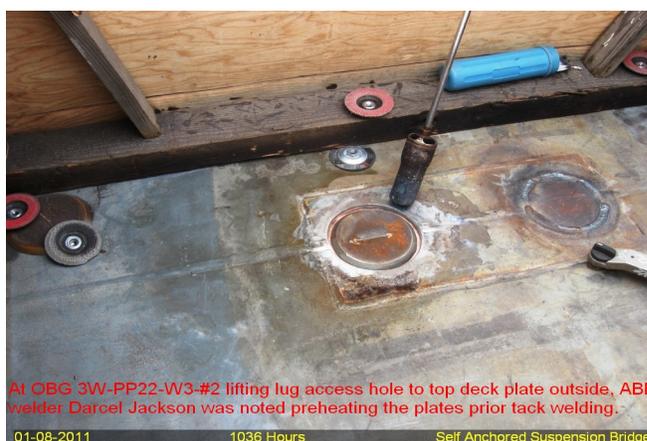
1. At OBG 2W-PP17-W4- #1 outside – ABF welder Mike Jimenez was observed continuing to perform 1G Shielded Metal Arc Welding (SMAW) back welding fill pass on the infill plate to top deck plate butt joint. The welder was noted using 5/32” diameter E7018H4R electrode. During the shift, fill pass welding was completed and the welder has moved to #3 LLAH of the same location and performed fit up/ tack welding of the infill plate to top deck plate. After the completion of the fit up, ABF QC Mike Johnson verified the alignment acceptable. QA has concurred the fit up alignment and the welder welded the root pass and followed by fill to cover pass. The welder was noted using 1/8” diameter E7018H4R electrode during the root pass and 5/32” diameter during fill to cover pass. This hole location was also completed and the welder has moved to new location OBG 3W-PP20-W4 #1 where he performed the same tasks as previously mentioned. At the end of the shift, the welder was still continuing to weld fill pass on the butt joint which should remain Monday.

2. At OBG 3W-PP22-W3- #1 and #2 outside - ABF welder Darcel Jackson was observed fit up/tack welding the infill plate to top deck plate. After the completion of the fit up, ABF QC Mike Johnson verified the alignment acceptable. QA has concurred the fit up alignment and the welder welded the root pass and followed by fill to cover pass. The welder was noted using 1/8” diameter E7018H4R electrode during root pass welding and used 3/16” diameter E7018H4R electrode during fill and cover pass welding. After completing the two LLAH, the

1. OBG 8W-PP70.5-W5-S deck access hole restoration outside – no defects noted.
2. OBG 4W-PP24.5-W5-S deck access hole restoration outside – no defects noted.
3. OBG 3W-PP23.5-W2-NE deck access hole restoration outside – no defects noted.
4. OBG 3W-PP19.5-W5-S deck access hole restoration outside – no defects noted.
