DEPARTMENT OF TRANSPORTATION

Contract #: 04-0120F4Cty: SF/ALA Rte: 80 PM: 13.2/13.9File #: 1.28**WELDING INSPECTION REPORT****Resident Engineer:** Siegenthaler, Peter**Address:** 333 Burma Road**City:** Oakland, CA 94607**Report No:** WIR-019220**Date Inspected:** 06-Jan-2011**Project Name:** SAS Superstructure**OSM Arrival Time:** 630**Prime Contractor:** American Bridge/Fluor Enterprises, a JV**OSM Departure Time:** 1500**Contractor:** American Bridge/Fluor Enterprises, a JV**Location:** Job Site**CWI Name:** See below**CWI Present:** Yes No**Inspected CWI report:** Yes No N/A**Rod Oven in Use:** Yes No N/A**Electrode to specification:** Yes No N/A**Weld Procedures Followed:** Yes No N/A**Qualified Welders:** Yes No N/A**Verified Joint Fit-up:** Yes No N/A**Approved Drawings:** Yes No N/A**Approved WPS:** Yes No N/A**Delayed / Cancelled:** Yes No N/A**Bridge No:** 34-0006**Component:** SAS OBG**Summary of Items Observed:**

WELDING INSPECTION REPORT

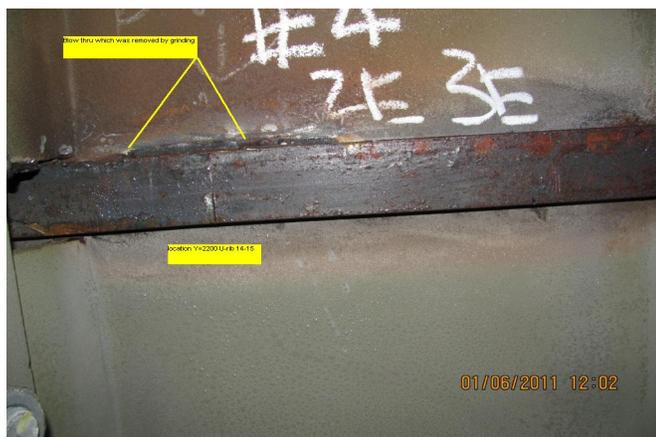
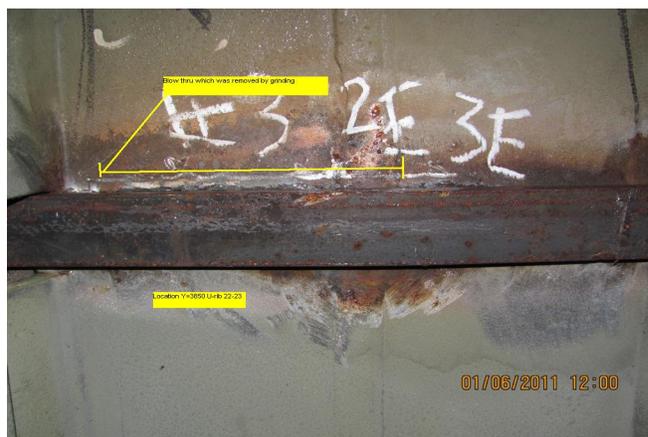
2E/3E-A & 6E/7E-A

The QA Inspector observed the contractor had begun to make repairs to the "blow thru" areas of the steel backing under the top deck plate at the above identified locations. The QA Inspector randomly observed the contractor had performed grinding tasks in an attempt to remove the dross created by the SAW blow thru. The QA Inspector noted no Engineering Representative of the department was notified of such repairs as required in the approved RFI 002290 R00. The QA Inspector notified the contractor an incident report would be written and submitted for review for the above identified non conforming issue. Below pictures illustrate an area of 2E/3E-A where such repairs were attempted.
