**DEPARTMENT OF TRANSPORTATION**

Contract #: 04-0120F4Cty: SF/ALA Rte: 80 PM: 13.2/13.9File #: 1.28**WELDING INSPECTION REPORT****Resident Engineer:** Siegenthaler, Peter**Address:** 333 Burma Road**City:** Oakland, CA 94607**Report No:** WIR-019222**Date Inspected:** 07-Jan-2011**Project Name:** SAS Superstructure**OSM Arrival Time:** 630**Prime Contractor:** American Bridge/Fluor Enterprises, a JV**OSM Departure Time:** 1500**Contractor:** American Bridge/Fluor Enterprises, a JV**Location:** Job Site**CWI Name:** See below**CWI Present:** Yes No**Inspected CWI report:** Yes No N/A**Rod Oven in Use:** Yes No N/A**Electrode to specification:** Yes No N/A**Weld Procedures Followed:** Yes No N/A**Qualified Welders:** Yes No N/A**Verified Joint Fit-up:** Yes No N/A**Approved Drawings:** Yes No N/A**Approved WPS:** Yes No N/A**Delayed / Cancelled:** Yes No N/A**Bridge No:** 34-0006**Component:** SAS OBG**Summary of Items Observed:**

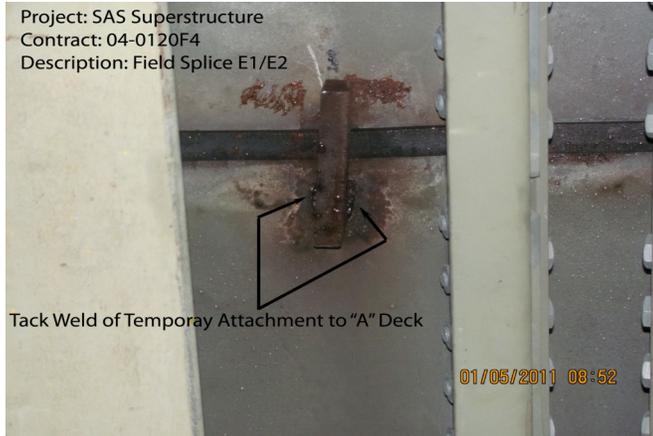
1E/2E-A

The QA Inspector randomly observed the ABF painting contractor setting up to paint the interior of the above identified weld joint. The QA Inspector performed a random visual inspection of the area and noted a temporary attachment or fitting aid remained in place under the top deck plate. The QA Inspector performed random dimensional measurement of the location of the attachment and noted it was approximately 500mm on the south side of the south longitudinal full depth stiffener. The QA Inspector wrote and submitted an incident report for the above identified issue.
