Contract #: 04-0120F4Cty: SF/ALA Rte: 80 PM: 13.2/13.9File #: 69.28**WELDING INSPECTION REPORT****Resident Engineer:** Siegenthaler, Peter**Address:** 333 Burma Road**City:** Oakland, CA 94607**Report No:** WIR-019227**Date Inspected:** 09-Jan-2011**Project Name:** SAS Superstructure**OSM Arrival Time:** 700**Prime Contractor:** American Bridge/Fluor Enterprises, a JV**OSM Departure Time:** 1900**Contractor:** Zhenhua Port Machinery Company, Ltd (ZPMC), Changxing Island **Location:** Shanghai, China**CWI Name:** Li Yang**CWI Present:** Yes No**Inspected CWI report:** Yes No N/A**Rod Oven in Use:** Yes No N/A**Electrode to specification:** Yes No N/A**Weld Procedures Followed:** Yes No N/A**Qualified Welders:** Yes No N/A**Verified Joint Fit-up:** Yes No N/A**Approved Drawings:** Yes No N/A**Approved WPS:** Yes No N/A**Delayed / Cancelled:** Yes No N/A**Bridge No:** 34-0006**Component:** OBG Segment**Summary of Items Observed:**

OBG # TRIAL ASSEMBLY YARD (Lift 11E)

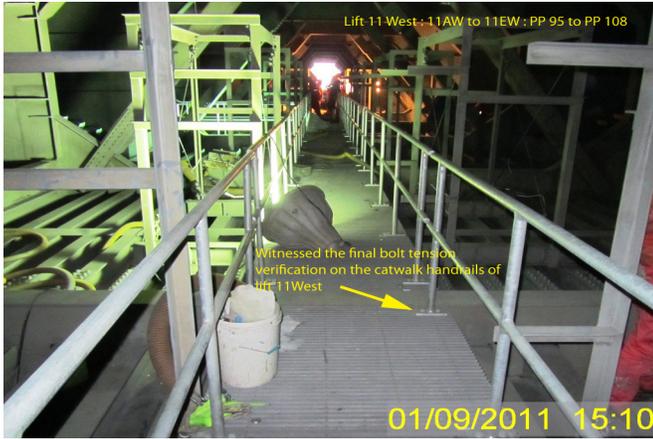
For additional information please reference the pictures below:
