DEPARTMENT OF TRANSPORTATION

Contract #: 04-0120F4Cty: SF/ALA Rte: 80 PM: 13.2/13.9File #: 69.28**WELDING INSPECTION REPORT****Resident Engineer:** Siegenthaler, Peter**Address:** 333 Burma Road**City:** Oakland, CA 94607**Report No:** WIR-019246**Date Inspected:** 12-Jan-2011**Project Name:** SAS Superstructure**OSM Arrival Time:** 700**Prime Contractor:** American Bridge/Fluor Enterprises, a JV**OSM Departure Time:** 1900**Contractor:** Zhenhua Port Machinery Company, Ltd (ZPMC), Changxing Island **Location:** Shanghai, China**CWI Name:** Lv Li Qing**CWI Present:** Yes No**Inspected CWI report:** Yes No N/A**Rod Oven in Use:** Yes No N/A**Electrode to specification:** Yes No N/A**Weld Procedures Followed:** Yes No N/A**Qualified Welders:** Yes No N/A**Verified Joint Fit-up:** Yes No N/A**Approved Drawings:** Yes No N/A**Approved WPS:** Yes No N/A**Delayed / Cancelled:** Yes No N/A**Bridge No:** 34-0006**Component:** OBG**Summary of Items Observed:**

WELDING INSPECTION REPORT

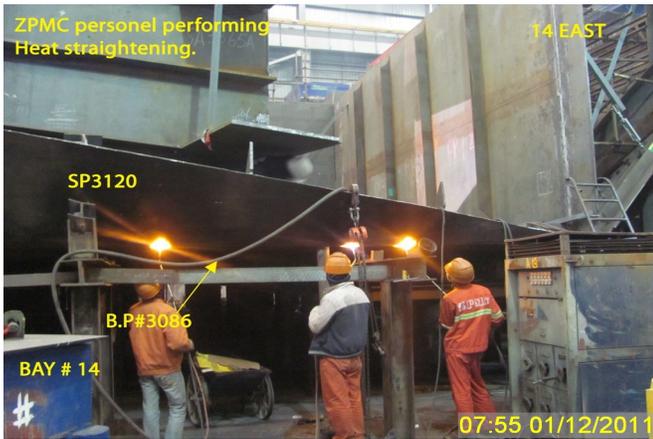
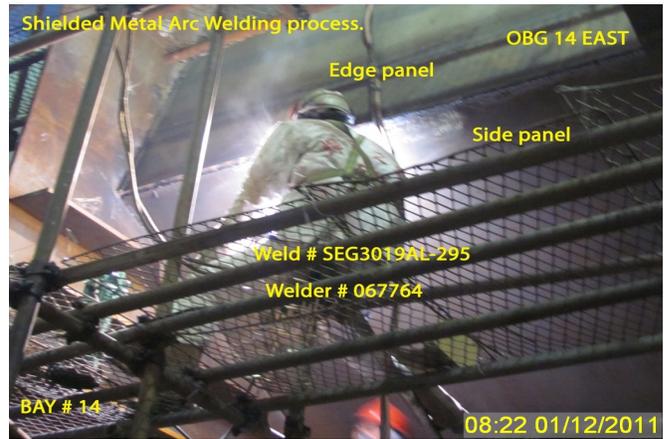
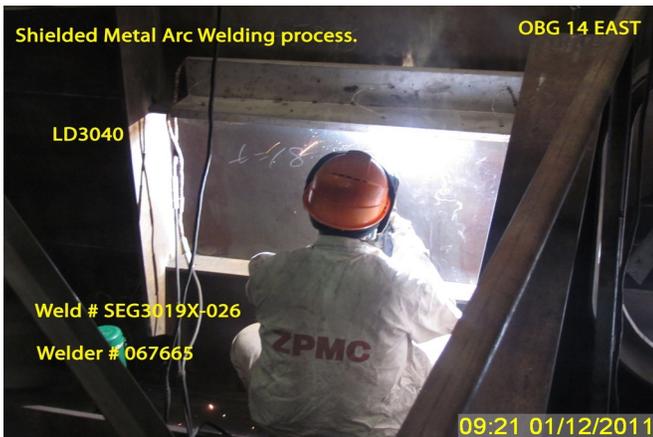
This Quality Assurance (QA) Inspector observed ZPMC personnel performing heat straightening, member identified as side plate (SP3120) and bottom plate (BP3086). Distortion appeared to be caused by welding. Weld number identified as SEG3019A-009. ZPMC Quality Control (QC) inspector identified as Mr. Lv Li Qing was present to monitor the heat straightening process. The heat straightening appeared to comply with heat straightening Report HSR1 (B)-448.
