DEPARTMENT OF TRANSPORTATION

Quality Assurance and Source Inspection

Contract #: 04-0120F4Cty: SF/ALA Rte: 80 PM: 13.2/13.9File #: 69.28**WELDING INSPECTION REPORT****Resident Engineer:** Siegenthaler, Peter**Address:** 333 Burma Road**City:** Oakland, CA 94607**Report No:** WIR-019254**Date Inspected:** 25-Nov-2010**Project Name:** SAS Superstructure**OSM Arrival Time:** 700**Prime Contractor:** American Bridge/Fluor Enterprises, a JV**OSM Departure Time:** 1900**Contractor:** Zhenhua Port Machinery Company, Ltd (ZPMC), Changxing Island **Location:** Shanghai, China**CWI Name:** Qiu Wen.**CWI Present:** Yes No**Inspected CWI report:** Yes No N/A**Rod Oven in Use:** Yes No N/A**Electrode to specification:** Yes No N/A**Weld Procedures Followed:** Yes No N/A**Qualified Welders:** Yes No N/A**Verified Joint Fit-up:** Yes No N/A**Approved Drawings:** Yes No N/A**Approved WPS:** Yes No N/A**Delayed / Cancelled:** Yes No N/A**Bridge No:** 34-0006**Component:** OBG components.**Summary of Items Observed:**

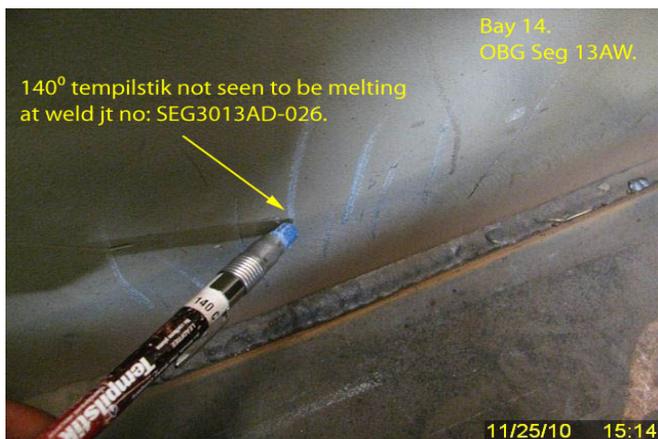
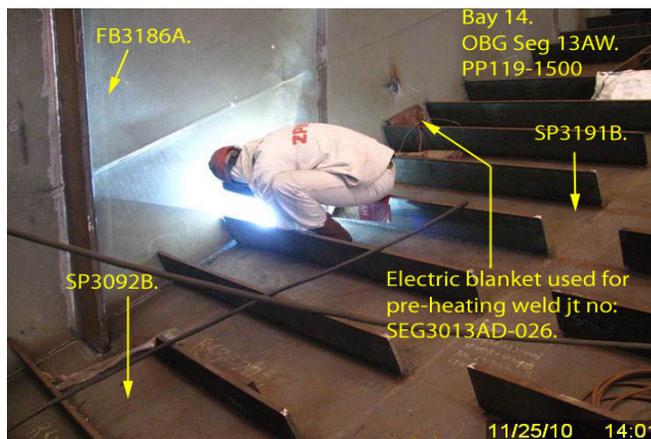
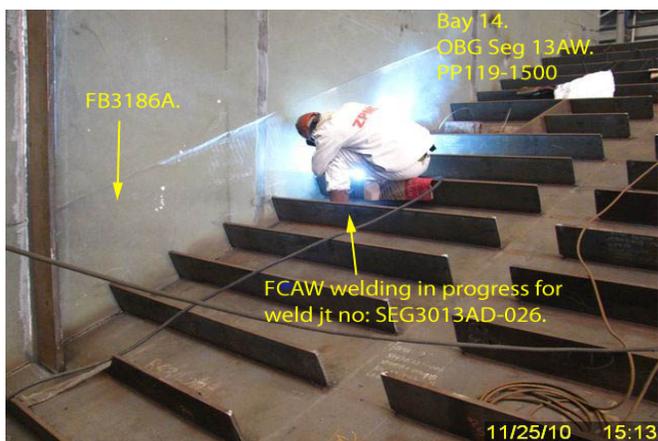
- Pre-heating was observed to be done using electric blankets.
- However, ZPMC personnel did not appear to be following the New Weld Procedure (Rager / McQuaid).

- Minimum pre heating temperature of 140C was not maintained when welding was in progress.
- This QA Inspector informed about this to ZPMC QC Qiu Wen, that an Incident Report will be raised for this.
- See attached photos for further details.
