DEPARTMENT OF TRANSPORTATION

Contract #: 04-0120F4Cty: SF/ALA Rte: 80 PM: 13.2/13.9File #: 69.28**WELDING INSPECTION REPORT****Resident Engineer:** Siegenthaler, Peter**Address:** 333 Burma Road**City:** Oakland, CA 94607**Report No:** WIR-019267**Date Inspected:** 23-Dec-2010**Project Name:** SAS Superstructure**OSM Arrival Time:** 700**Prime Contractor:** American Bridge/Fluor Enterprises, a JV**OSM Departure Time:** 1900**Contractor:** Zhenhua Port Machinery Company, Ltd (ZPMC), Changxing Island **Location:** Shanghai, China**CWI Name:** Qiu Wen.**CWI Present:** Yes No**Inspected CWI report:** Yes No N/A**Rod Oven in Use:** Yes No N/A**Electrode to specification:** Yes No N/A**Weld Procedures Followed:** Yes No N/A**Qualified Welders:** Yes No N/A**Verified Joint Fit-up:** Yes No N/A**Approved Drawings:** Yes No N/A**Approved WPS:** Yes No N/A**Delayed / Cancelled:** Yes No N/A**Bridge No:** 34-0006**Component:** OBG components.**Summary of Items Observed:**

WELDING INSPECTION REPORT

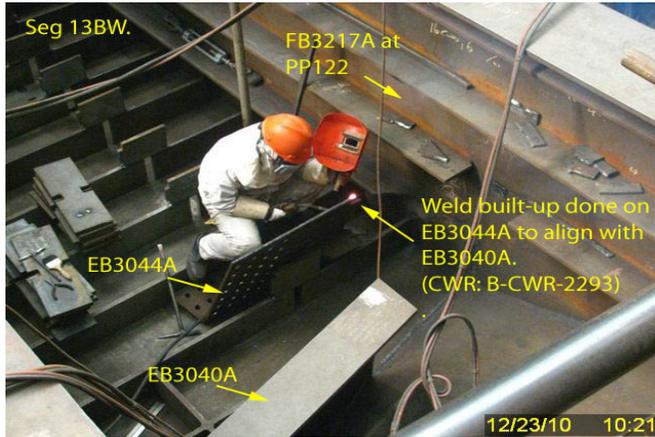
ZPMC personnel performing weld built-up on Edge Beam (EB) 3044A at PP122. EB3044A was needed to be removed and re-align with EB3040A to correct the mis-alignment after welding. Repair welding was done as per Critical Welding report (CWR): B-CWR-2293 Rev-0. The welder is identified as 201583. Welding process was identified as FCAW. See attached photo for details.
