DEPARTMENT OF TRANSPORTATION

Quality Assurance and Source Inspection

Contract #: 04-0120F4Cty: SF/ALA Rte: 80 PM: 13.2/13.9File #: 69.28**WELDING INSPECTION REPORT****Resident Engineer:** Siegenthaler, Peter**Address:** 333 Burma Road**City:** Oakland, CA 94607**Report No:** WIR-019298**Date Inspected:** 12-Jan-2011**Project Name:** SAS Superstructure**OSM Arrival Time:** 700**Prime Contractor:** American Bridge/Fluor Enterprises, a JV**OSM Departure Time:** 1900**Contractor:** Zhenhua Port Machinery Company, Ltd (ZPMC), Changxing Island **Location:** Shanghai, China**CWI Name:** Liu Hua Jie**CWI Present:** Yes No**Inspected CWI report:** Yes No N/A**Rod Oven in Use:** Yes No N/A**Electrode to specification:** Yes No N/A**Weld Procedures Followed:** Yes No N/A**Qualified Welders:** Yes No N/A**Verified Joint Fit-up:** Yes No N/A**Approved Drawings:** Yes No N/A**Approved WPS:** Yes No N/A**Delayed / Cancelled:** Yes No N/A**Bridge No:** 34-0006**Component:** OBG COMPONENT**Summary of Items Observed:**

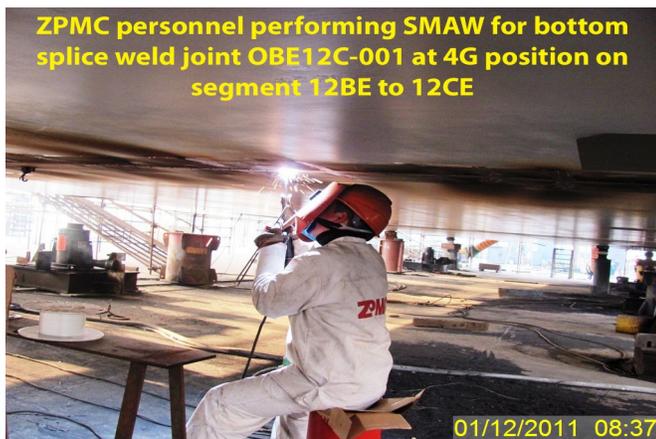
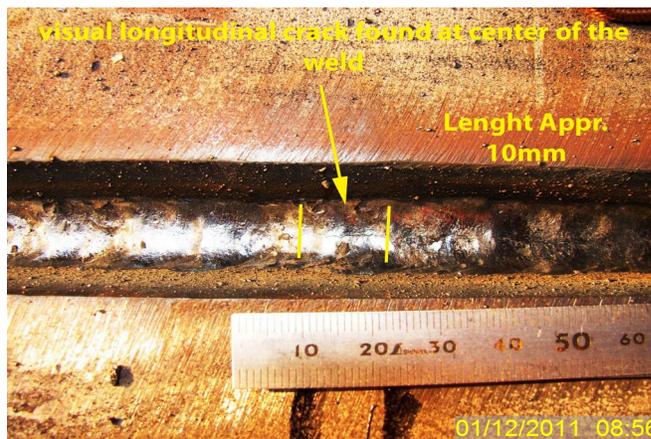
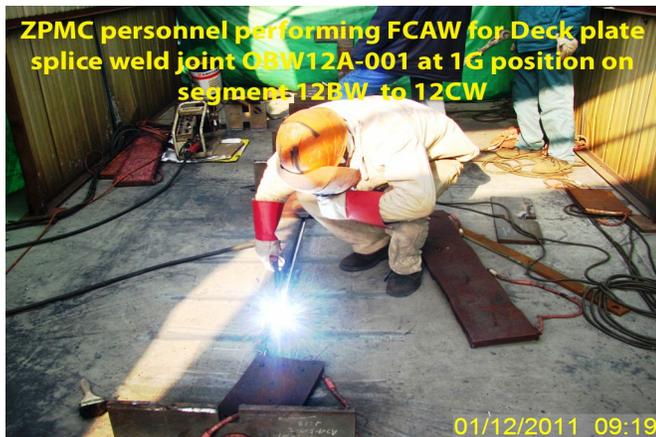
During random visual inspection at trial assembly area, before root pass welding of splice joint OBE12A-001, this QA inspector verified the root opening of this joint and found accepted according to the approved WPS. The data recorded for root opening approx. 8~12 mm. And after root pass this QA found lots of visual longitudinal crack found at center of the weld and informed to ZPMC QC and ABF QA to verify with magnetic particle testing. The QA witnessed the MPT and recorded all Y location of repaired area for future verification. For details please refer the attached photo.
