DEPARTMENT OF TRANSPORTATION

Contract #: 04-0120F4Cty: SF/ALA Rte: 80 PM: 13.2/13.9File #: 99.28**WELDING INSPECTION REPORT****Resident Engineer:** Siegenthaler, Peter**Address:** 333 Burma Road**City:** Oakland, CA 94607**Report No:** WIR-019312**Date Inspected:** 11-Jan-2011**Project Name:** SAS Superstructure**OSM Arrival Time:** 700**Prime Contractor:** American Bridge/Fluor Enterprises, a JV**OSM Departure Time:** 1900**Contractor:** Zhenhua Port Machinery Company, Ltd (ZPMC) Chanxing Island**Location:** Shanghai, China**CWI Name:** Mr. Qui Wen**CWI Present:** Yes No**Inspected CWI report:** Yes No N/A**Rod Oven in Use:** Yes No N/A**Electrode to specification:** Yes No N/A**Weld Procedures Followed:** Yes No N/A**Qualified Welders:** Yes No N/A**Verified Joint Fit-up:** Yes No N/A**Approved Drawings:** Yes No N/A**Approved WPS:** Yes No N/A**Delayed / Cancelled:** Yes No N/A**Bridge No:** 34-0006**Component:** OBG Segment**Summary of Items Observed:**

WELDING INSPECTION REPORT

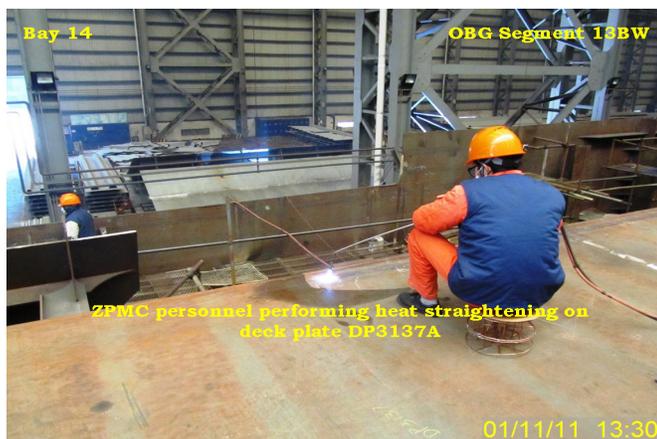
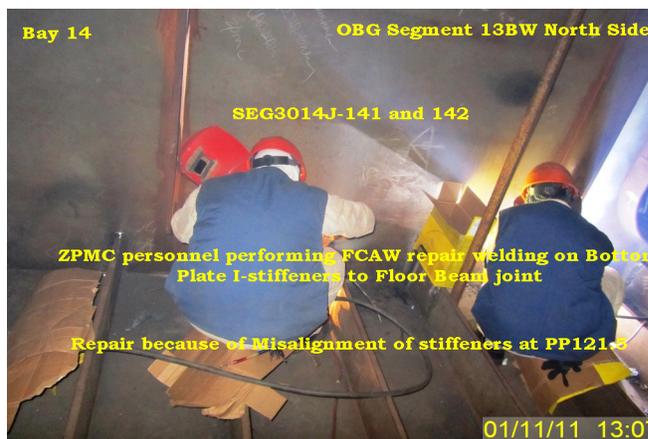
ZPMC personnel performing heat straightening on deck plate of OBG Segment 13BW member identified as DP3137A. Distortion appeared to be caused by mishandling of the welding/material. ZPMC Quality Control (QC) inspector identified as Mr. Qui Wen was present to monitor the heat straightening process. The heat straightening appeared to comply with HSR1 (B) number 10040. See the attached picture.
