**DEPARTMENT OF TRANSPORTATION**

Contract #: 04-0120F4Cty: SF/ALA Rte: 80 PM: 13.2/13.9File #: 69.28**WELDING INSPECTION REPORT****Resident Engineer:** Siegenthaler, Peter**Address:** 333 Burma Road**City:** Oakland, CA 94607**Report No:** WIR-019319**Date Inspected:** 15-Jan-2011**Project Name:** SAS Superstructure**OSM Arrival Time:** 700**Prime Contractor:** American Bridge/Fluor Enterprises, a JV**OSM Departure Time:** 1900**Contractor:** Zhenhua Port Machinery Company, Ltd (ZPMC), Changxing Island **Location:** Shanghai, China**CWI Name:** Xu Le Feng**CWI Present:** Yes No**Inspected CWI report:** Yes No N/A**Rod Oven in Use:** Yes No N/A**Electrode to specification:** Yes No N/A**Weld Procedures Followed:** Yes No N/A**Qualified Welders:** Yes No N/A**Verified Joint Fit-up:** Yes No N/A**Approved Drawings:** Yes No N/A**Approved WPS:** Yes No N/A**Delayed / Cancelled:** Yes No N/A**Bridge No:** 34-0006**Component:** OBG**Summary of Items Observed:**

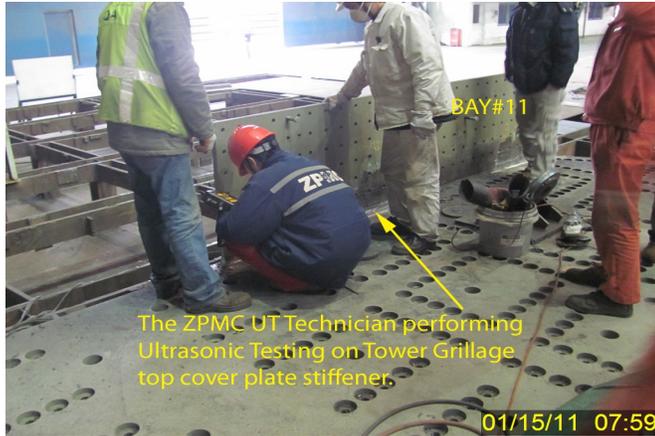
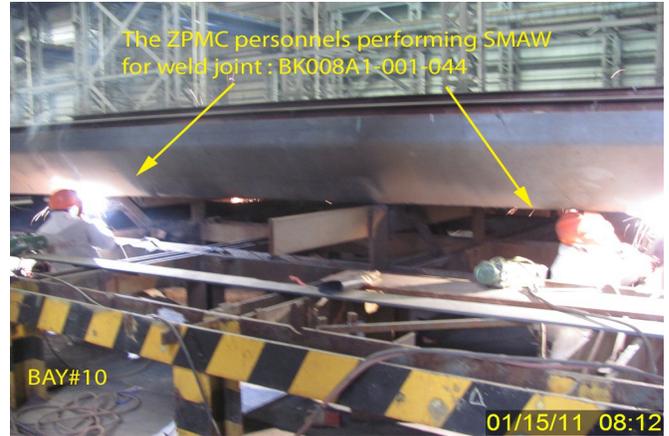
SMAW in the 1G position for the OBG Bike path. The weld joint was designated as: BK008A1-001-044. The welders are identified as 044511 and 052493. ZPMC QC is identified as Mr. Li Jun. The welding variables recorded by QC appear to comply with WPS-B-P-2211-B-U2. Please see the attached picture.
