**DEPARTMENT OF TRANSPORTATION**

Contract #: 04-0120F4Cty: SF/ALA Rte: 80 PM: 13.2/13.9File #: 1.28**WELDING INSPECTION REPORT****Resident Engineer:** Siegenthaler, Peter**Address:** 333 Burma Road**City:** Oakland, CA 94607**Report No:** WIR-019343**Date Inspected:** 14-Jan-2011**Project Name:** SAS Superstructure**OSM Arrival Time:** 900**Prime Contractor:** American Bridge/Fluor Enterprises, a JV**OSM Departure Time:** 1730**Contractor:** American Bridge/Fluor Enterprises, a JV**Location:** Job Site**CWI Name:** Gary Ershan and Pat Swain**CWI Present:** Yes No**Inspected CWI report:** Yes No N/A**Rod Oven in Use:** Yes No N/A**Electrode to specification:** Yes No N/A**Weld Procedures Followed:** Yes No N/A**Qualified Welders:** Yes No N/A**Verified Joint Fit-up:** Yes No N/A**Approved Drawings:** Yes No N/A**Approved WPS:** Yes No N/A**Delayed / Cancelled:** Yes No N/A**Bridge No:** 34-0006**Component:** Orthotropic Box Girder**Summary of Items Observed:**

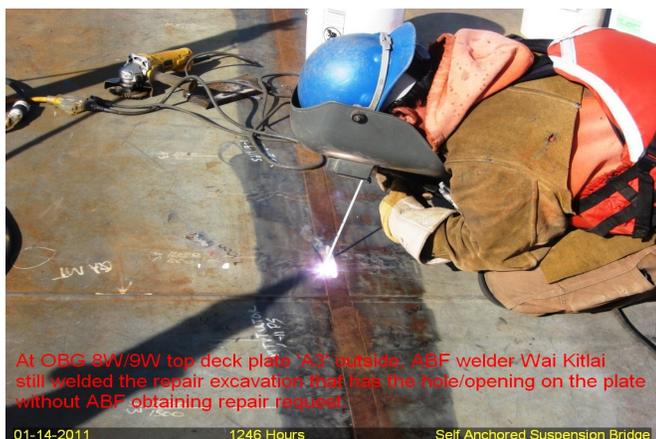
01-14-2011 1246 Hours Self Anchored Suspension Bridge

At OBG 8W/9W top deck plate 'A3' outside, ABF welder Wai Kitlai still welded the repair excavation that has the hole/opening on the plate without ABF obtaining repair request.

Prior to the repair welding at this location 8W/9W top deck plate 'A3', QA consulted with Lead QA Rick Bettencourt about the procedure for welding repair with burn through or excessive grinding since this particular weld repair has a hole due to excessive grinding behind the backing bar. ABF needs to make a repair request with Engineer's approval since this repair does not only involve the weld defect but also includes a base metal repair. QC Inspector Pat Swain informed QA this has happened before on similar joints which the Engineer had approved. Per Pat Swain, he will not stop the welder to perform the repair and the repair request will be followed at a later time. The welder performed the repair and was completed. QA issued an incident report for the repair being made without engineer approval.

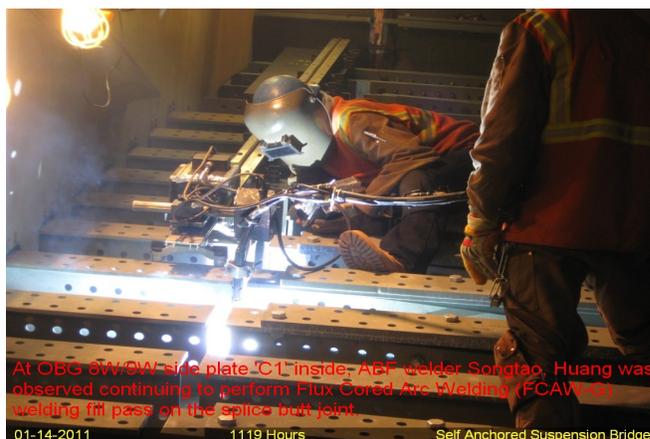
01-14-2011 1119 Hours Self Anchored Suspension Bridge

At OBG 8W/9W side plate 'C1' inside, ABF welder Sungtao, Huang was observed continuing to perform Flux Cored Arc Welding (FCAW-G) welding fill pass on the splice butt joint.
