**DEPARTMENT OF TRANSPORTATION**

Quality Assurance and Source Inspection

Contract #: 04-0120F4Cty: SF/Ala Rte: 80 PM: 13.2/13.9File #: 69.28**WELDING INSPECTION REPORT****Resident Engineer:** Siegenthaler, Peter**Address:** 333 Burma Road**City:** Oakland, CA 94607**Report No:** WIR-019357**Date Inspected:** 03-Jan-2011**Project Name:** SAS Superstructure**OSM Arrival Time:** 1900**Prime Contractor:** American Bridge/Fluor Enterprises, a JV**OSM Departure Time:** 700**Contractor:** Zhenhua Port Machinery Company, Ltd (ZPMC), Changxing Island **Location:** Shanghai, China**CWI Name:** See below**CWI Present:** Yes No**Inspected CWI report:** Yes No N/A**Rod Oven in Use:** Yes No N/A**Electrode to specification:** Yes No N/A**Weld Procedures Followed:** Yes No N/A**Qualified Welders:** Yes No N/A**Verified Joint Fit-up:** Yes No N/A**Approved Drawings:** Yes No N/A**Approved WPS:** Yes No N/A**Delayed / Cancelled:** Yes No N/A**Bridge No:** 34-0006**Component:** Tower and OBG Components**Summary of Items Observed:**

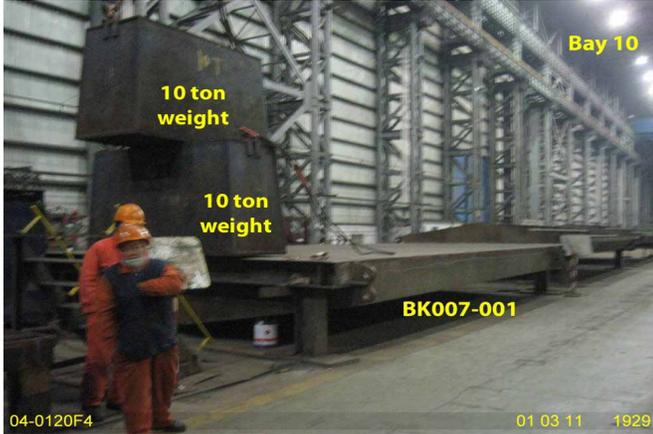
ZPMC workers were performing match drilling operations at the top of east and south towers, lift 5, skin D and drilling various other parts at the floor level, all using magnetically attached drill presses. See photo below.

Heat straightening of the deck plate located on BK007-001. QC was identified as Fu Guo Gang (QC1). Assisting QC1 at this location and appearing to be monitoring the heat straightening operation and recording data was (QCA1), who was not a CWI. Heat treatment variables recorded by QCA1 appeared to comply with ZPMC document HSR1(B)-9656 as presented to this QA Inspector and verbally identified by QCA1. Two 10 ton weights were stacked at one end of the bikepath deck plate assembly after heat treatment. See photo below.
