DEPARTMENT OF TRANSPORTATION

Quality Assurance and Source Inspection

Contract #: 04-0120F4Cty: SF/Ala Rte: 80 PM: 13.2/13.9File #: 69.28**WELDING INSPECTION REPORT****Resident Engineer:** Siegenthaler, Peter**Address:** 333 Burma Road**City:** Oakland, CA 94607**Report No:** WIR-019362**Date Inspected:** 09-Jan-2011**Project Name:** SAS Superstructure**OSM Arrival Time:** 1900**Prime Contractor:** American Bridge/Fluor Enterprises, a JV**OSM Departure Time:** 700**Contractor:** Zhenhua Port Machinery Company, Ltd (ZPMC), Changxing Island **Location:** Shanghai, China**CWI Name:** See below**CWI Present:** Yes No**Inspected CWI report:** Yes No N/A**Rod Oven in Use:** Yes No N/A**Electrode to specification:** Yes No N/A**Weld Procedures Followed:** Yes No N/A**Qualified Welders:** Yes No N/A**Verified Joint Fit-up:** Yes No N/A**Approved Drawings:** Yes No N/A**Approved WPS:** Yes No N/A**Delayed / Cancelled:** Yes No N/A**Bridge No:** 34-0006**Component:** Tower and OBG Components**Summary of Items Observed:**

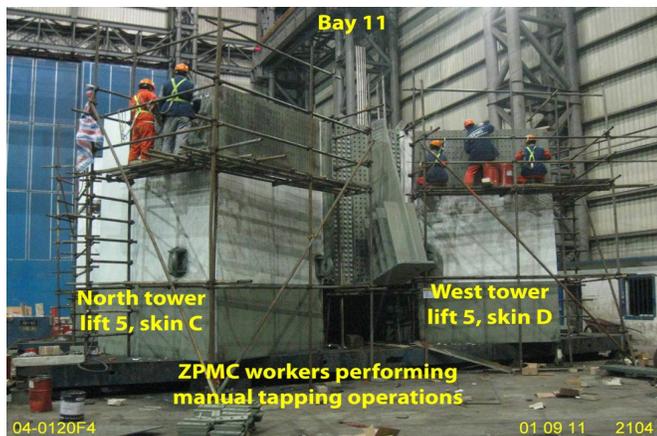
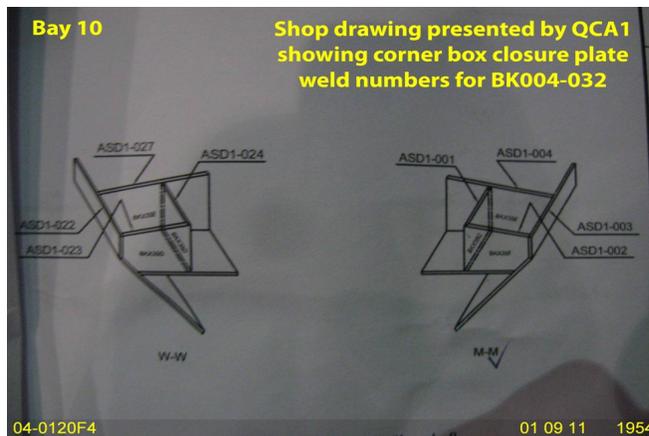
ZPMC workers were performing installation of bolt sets connecting the transverse diaphragms to the grillage connection plates of the north tower and east tower, lift 5, skins A and what appeared to be initial tightening to a snug tight condition using an air impact gun. ZPMC workers were creating threads by manually tapping the previously drilled holes in north tower, near the top of skin C and west tower, near the top of skin D. See photo of tapping operations below.
