**DEPARTMENT OF TRANSPORTATION**

Contract #: 04-0120F4Cty: SF/Ala Rte: 80 PM: 13.2/13.9File #: 69.28**WELDING INSPECTION REPORT****Resident Engineer:** Siegenthaler, Peter**Address:** 333 Burma Road**City:** Oakland, CA 94607**Report No:** WIR-019363**Date Inspected:** 10-Jan-2011**Project Name:** SAS Superstructure**OSM Arrival Time:** 1900**Prime Contractor:** American Bridge/Fluor Enterprises, a JV**OSM Departure Time:** 700**Contractor:** Zhenhua Port Machinery Company, Ltd (ZPMC), Changxing Island **Location:** Shanghai, China**CWI Name:** See below**CWI Present:** Yes No**Inspected CWI report:** Yes No N/A**Rod Oven in Use:** Yes No N/A**Electrode to specification:** Yes No N/A**Weld Procedures Followed:** Yes No N/A**Qualified Welders:** Yes No N/A**Verified Joint Fit-up:** Yes No N/A**Approved Drawings:** Yes No N/A**Approved WPS:** Yes No N/A**Delayed / Cancelled:** Yes No N/A**Bridge No:** 34-0006**Component:** Tower and OBG Components**Summary of Items Observed:**

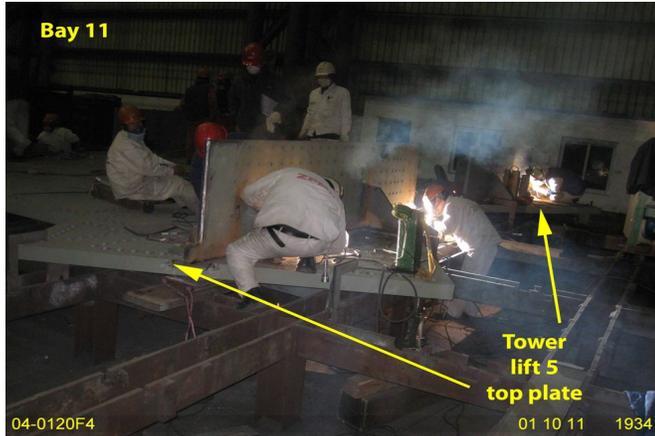
SMAW welding of weld joint GTSA5-B/G-11A located on PCMK tower, lift 5, top plate. Welders were identified as 044541, 040690. QC was identified as QC1. Assisting QC1 at this location and appearing to be monitoring the welding operation and recording data was Shi Yu (QCA2), who was not a CWI. Weld variables recorded by QCA2 appeared to comply with WPS-B-P-2212-TC-U5b as verbally identified by QCA2. See photo below showing the tower, lift 5, top plate welding operations.
