DEPARTMENT OF TRANSPORTATION

Contract #: 04-0120F4Cty: SF/Ala Rte: 80 PM: 13.2/13.9File #: 69.28**WELDING INSPECTION REPORT****Resident Engineer:** Siegenthaler, Peter**Address:** 333 Burma Road**City:** Oakland, CA 94607**Report No:** WIR-019368**Date Inspected:** 16-Jan-2011**Project Name:** SAS Superstructure**OSM Arrival Time:** 1900**Prime Contractor:** American Bridge/Fluor Enterprises, a JV**OSM Departure Time:** 700**Contractor:** Zhenhua Port Machinery Company, Ltd (ZPMC), Changxing Island **Location:** Shanghai, China

WELDING INSPECTION REPORT

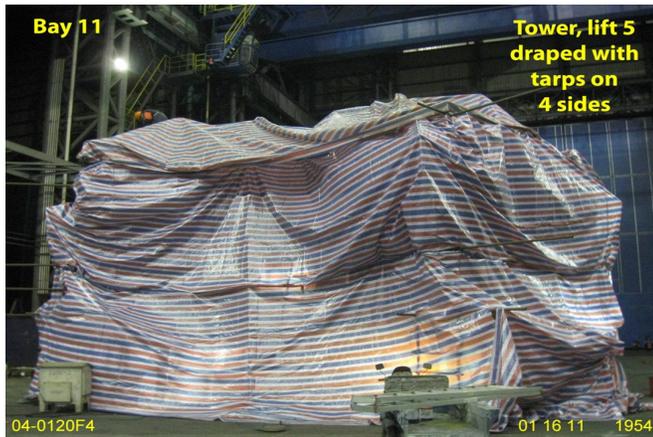
Bay 11

Tower, lift 5 was positioned on stanchions and covered on the four sides with plastic tarps. The 100+mm top plate was in place. See photo below. A blower was feeding air inside the tarped area through an approximate 400mm duct. The skin of the duct measured approximately 20°C and felt warm to the touch. ZPMC workers were inside the tarped area performing touch-up painting using brushes and rollers. Other ZPMC workers were also inside the tarped area and on top of the top plate and performing installation of ASTM A325M bolt sets and what appeared to be initial tightening (snug tight) using an air operated impact wrench.
