Contract #: 04-0120F4Cty: SF/ALA Rte: 80 PM: 13.2/13.9File #: 82.28**WELDING INSPECTION REPORT****Resident Engineer:** Siegenthaler, Peter**Address:** 333 Burma Road**City:** Oakland, CA 94607**Report No:** WIR-019374**Date Inspected:** 08-Jan-2011**Project Name:** SAS Superstructure**OSM Arrival Time:** 500**Prime Contractor:** American Bridge/Fluor Enterprises, a JV**OSM Departure Time:** 1330**Contractor:** Westmont Industries**Location:** Santa Fe Springs, CA.**CWI Name:** Ruben Dominguez**CWI Present:** Yes No**Inspected CWI report:** Yes No N/A**Rod Oven in Use:** Yes No N/A**Electrode to specification:** Yes No N/A**Weld Procedures Followed:** Yes No N/A**Qualified Welders:** Yes No N/A**Verified Joint Fit-up:** Yes No N/A**Approved Drawings:** Yes No N/A**Approved WPS:** Yes No N/A**Delayed / Cancelled:** Yes No N/A**Bridge No:** 34-0006**Component:** Travelers**Summary of Items Observed:**

SAS-EB Traveler

E2/E3-EB Traveler

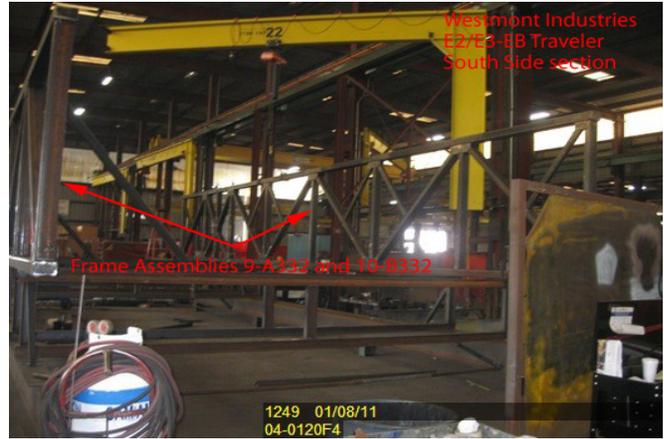
On this date, the QA Inspector observed WMI production welder Mr. Cesar Canales (WID # 3195) performing fitting and Flux Core Arc Welding (FCAW) tacking activities on the Frame Assembly identified as 8-B327, per the shop drawings. The QA Inspector observed that the material appeared to be identified as diagonal and intermediate Tube Steel (TS) material. Additionally, the QA Inspector observed Mr. Canales performing fitting activities on the previously completed Frame Assemblies identified as 9-A332 and 10-B332. During observation the QA Inspector observed Mr. Canales utilize the overhead shop bay crane, chain and hook to lift the above mentioned assemblies. Once lifted, the QA Inspector observed Mr. Canales then place the assemblies on previously fabricated stands, in an upright fashion. The QA Inspector then observed Mr. Canales and a helper utilize various lengths of angle material, to temporarily stabilize the upright assemblies. The QA Inspector noted that this appears to be designated as the South Side section, per the Shop Drawings.
