**DEPARTMENT OF TRANSPORTATION**

Contract #: 04-0120F4Cty: SF/ALA Rte: 80 PM: 13.2/13.9File #: 1.28**WELDING INSPECTION REPORT****Resident Engineer:** Siegenthaler, Peter**Address:** 333 Burma Road**City:** Oakland, CA 94607**Report No:** WIR-019378**Date Inspected:** 11-Jan-2011**Project Name:** SAS Superstructure**OSM Arrival Time:** 630**Prime Contractor:** American Bridge/Fluor Enterprises, a JV**OSM Departure Time:** 1500**Contractor:** American Bridge/Fluor Enterprises, a JV**Location:** Job Site**CWI Name:** See Below**CWI Present:** Yes No**Inspected CWI report:** Yes No N/A**Rod Oven in Use:** Yes No N/A**Electrode to specification:** Yes No N/A**Weld Procedures Followed:** Yes No N/A**Qualified Welders:** Yes No N/A**Verified Joint Fit-up:** Yes No N/A**Approved Drawings:** Yes No N/A**Approved WPS:** Yes No N/A**Delayed / Cancelled:** Yes No N/A**Bridge No:** 34-0006**Component:** Orthotropic Box Girders**Summary of Items Observed:**

# WELDING INSPECTION REPORT

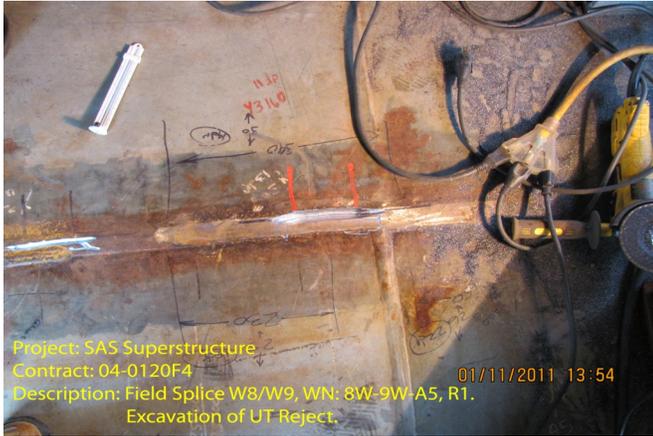
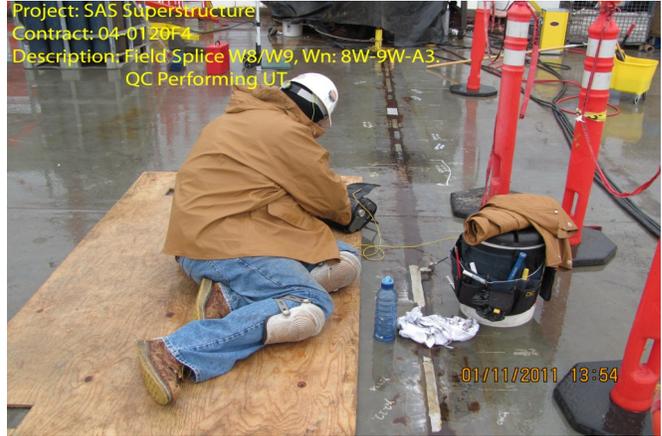
The digital photographs below illustrate some of the work observed during this scheduled shift.
