**DEPARTMENT OF TRANSPORTATION**

Contract #: 04-0120F4Cty: SF/ALA Rte: 80 PM: 13.2/13.9File #: 69.28**WELDING INSPECTION REPORT****Resident Engineer:** Siegenthaler, Peter**Address:** 333 Burma Road**City:** Oakland, CA 94607**Report No:** WIR-019418**Date Inspected:** 17-Jan-2011**Project Name:** SAS Superstructure**OSM Arrival Time:** 700**Prime Contractor:** American Bridge/Fluor Enterprises, a JV**OSM Departure Time:** 1900**Contractor:** Zhenhua Port Machinery Company, Ltd (ZPMC), Changxing Island **Location:** Shanghai, China**CWI Name:** Mr. An Qing xiang**CWI Present:** Yes No**Inspected CWI report:** Yes No N/A**Rod Oven in Use:** Yes No N/A**Electrode to specification:** Yes No N/A**Weld Procedures Followed:** Yes No N/A**Qualified Welders:** Yes No N/A**Verified Joint Fit-up:** Yes No N/A**Approved Drawings:** Yes No N/A**Approved WPS:** Yes No N/A**Delayed / Cancelled:** Yes No N/A**Bridge No:** 34-0006**Component:** Orthotropic Box Girder (OBG)**Summary of Items Observed:**

## WELDING INSPECTION REPORT

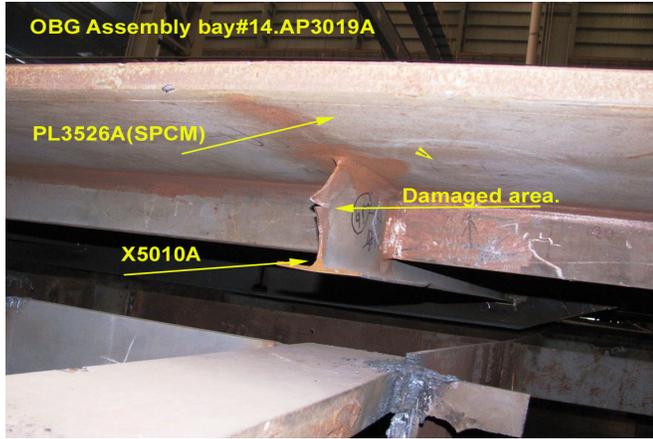
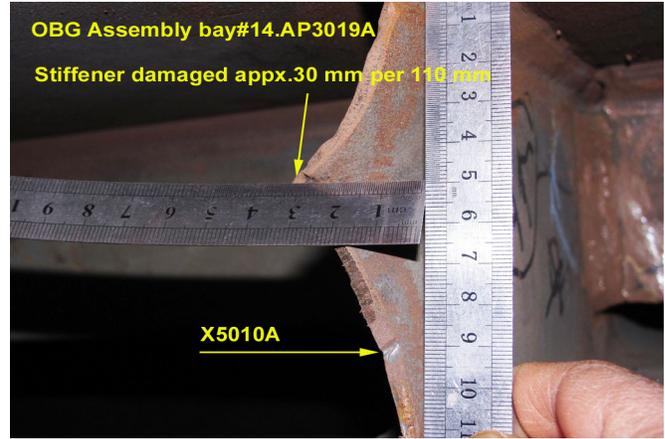
During the QA random in-process observations of the fabrication of OBG Lift 14 West Anchor plate (AP) AP3019A, this QA observed one open Rib Stiffener base material was bent due to improper handling of the material. The stiffener is identified as X5010A. The deformation measured to be approximately 30 mm per 110 mm length from the flat surface. This stiffener is welded to plate identified as PL3526A (SPCM). This QA informed to Lead QA for this issue. Refer the attached photos for more information.
