**DEPARTMENT OF TRANSPORTATION**

Contract #: 04-0120F4Cty: SF/ALA Rte: 80 PM: 13.2/13.9File #: 1.28**WELDING INSPECTION REPORT****Resident Engineer:** Siegenthaler, Peter**Address:** 333 Burma Road**City:** Oakland, CA 94607**Report No:** WIR-019448**Date Inspected:** 12-Jan-2011**Project Name:** SAS Superstructure**OSM Arrival Time:** 630**Prime Contractor:** American Bridge/Fluor Enterprises, a JV**OSM Departure Time:** 1500**Contractor:** American Bridge/Fluor Enterprises, a JV**Location:** Job Site**CWI Name:** See Below**CWI Present:** Yes No**Inspected CWI report:** Yes No N/A**Rod Oven in Use:** Yes No N/A**Electrode to specification:** Yes No N/A**Weld Procedures Followed:** Yes No N/A**Qualified Welders:** Yes No N/A**Verified Joint Fit-up:** Yes No N/A**Approved Drawings:** Yes No N/A**Approved WPS:** Yes No N/A**Delayed / Cancelled:** Yes No N/A**Bridge No:** 34-0006**Component:** Orthotropic Box Girders**Summary of Items Observed:**

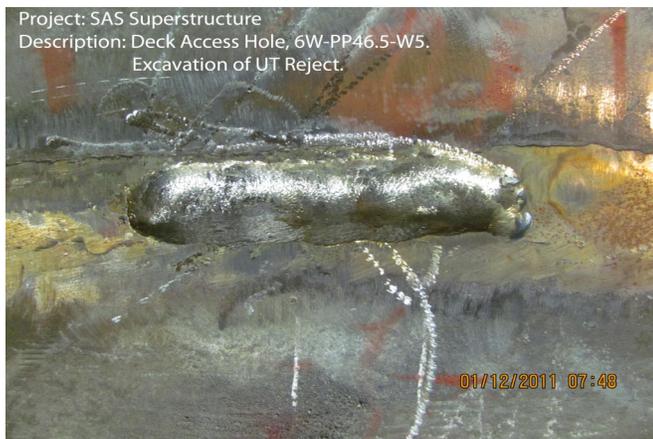
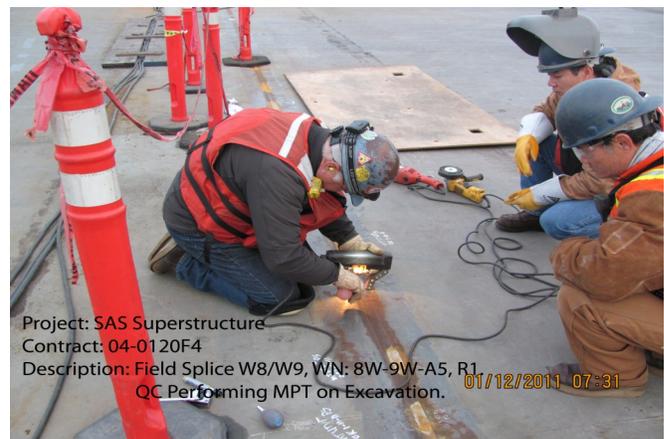
The digital photographs below illustrate some of the work observed during this scheduled shift.
