DEPARTMENT OF TRANSPORTATION

Office of Structural Materials

Contract #: 04-0120F4Cty: SF/ALA Rte: 80 PM: 13.2/13.9File #: 1.28**WELDING INSPECTION REPORT****Resident Engineer:** Siegenthaler, Peter**Address:** 333 Burma Road**City:** Oakland, CA 94607**Report No:** WIR-019460**Date Inspected:** 19-Jan-2011**Project Name:** SAS Superstructure**OSM Arrival Time:** 630**Prime Contractor:** American Bridge/Fluor Enterprises, a JV**OSM Departure Time:** 1500**Contractor:** American Bridge/Fluor Enterprises, a JV**Location:** Job Site**CWI Name:** See below**CWI Present:** Yes No**Inspected CWI report:** Yes No N/A**Rod Oven in Use:** Yes No N/A**Electrode to specification:** Yes No N/A**Weld Procedures Followed:** Yes No N/A**Qualified Welders:** Yes No N/A**Verified Joint Fit-up:** Yes No N/A**Approved Drawings:** Yes No N/A**Approved WPS:** Yes No N/A**Delayed / Cancelled:** Yes No N/A**Bridge No:** 34-0006**Component:** SAS OBG**Summary of Items Observed:**

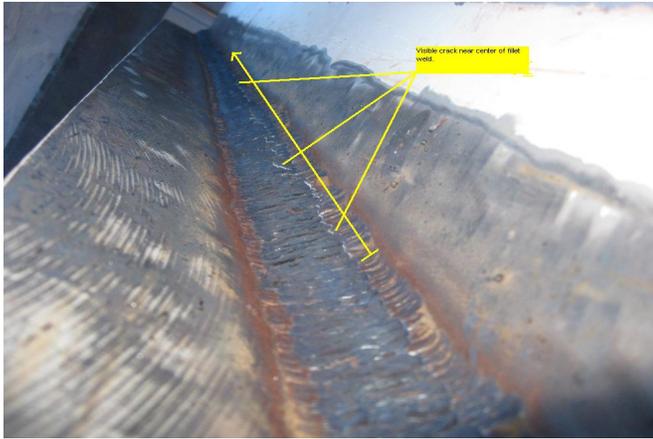
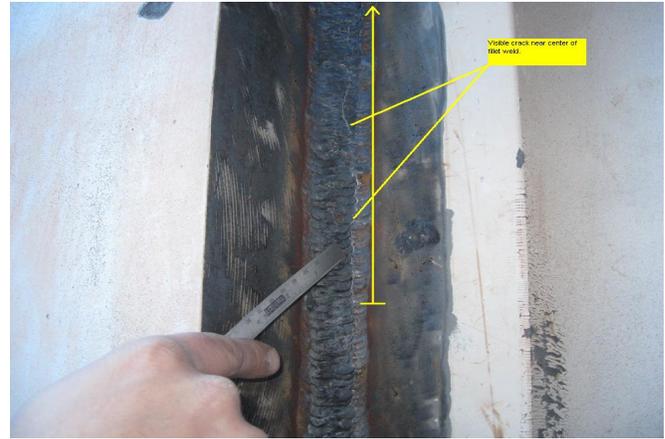
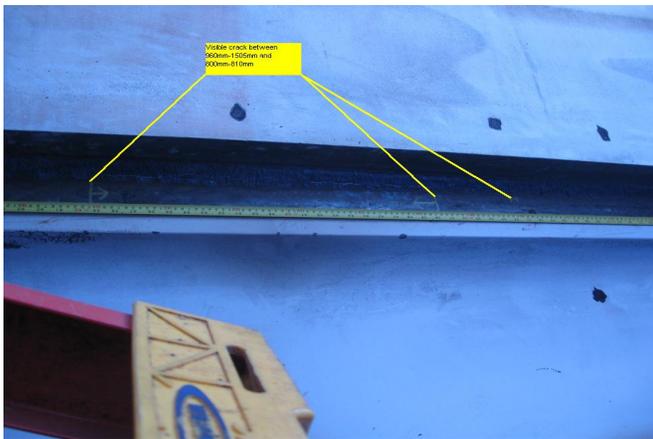
The QA Inspector arrived at the above identified location at 1030 to observe the preheat and perform visual testing of the opposite side of the jack frame (west) weld joint. The QA Inspector was informed the West weld joint was in preparation to be welded at 1030. Upon the arrival the QA Inspector randomly observed the Jacking Frame to Saddle fillet weld (East side) fillet weld and noted the completed fillet weld appeared to be cracked between the toe and the center of the weld. The QA Inspector performed dimensional measurements of the cracked area and noted the crack started at 800mm-810mm and 960mm-1505mm measurements taken from the top down. The QA Inspector notified the QA Task Lead Inspector Bill Levell and Lead QC Inspector Leonard Cross. The QA Inspector noted the induction heating blankets on the opposite side of the jacking frame at the West weld joint were turned on and began heating the steel for welding at 1000. The QA Inspector noted the crack was discovered at

1030 by the Lead QA Inspector Rick Bettencourt. The QA Inspector noted the temperature of the steel when the crack was discovered was approximately 250°F.

The QA Inspector randomly observed the ABF welder Rick Clayborn begin the excavation and removal of the crack in the above identified fillet weld. The QA Inspector noted the ABF welder was utilizing a carbon air arc to remove the weld material indicated by the SE QC Inspector Mike Johnson and Leonard Cross. The QA Inspector noted the excavation was stopped by the ABF Engineer John Callaghan. The QA Inspector noted the cracked area of weld was only partially excavated and visible cracked weld was still present in the weld joint at the end of the shift.

The QA Inspector spoke with the QA Task Lead Inspector Bill Levell and Mr. Levell informed the QA Inspector the approval was given to excavate the cracked fillet weld at 1145 per the Structures Material Representative Patrick Lowry.
