Contract #: 04-0120F4Cty: SF/ALA Rte: 80 PM: 13.2/13.9File #: 1.28**WELDING INSPECTION REPORT****Resident Engineer:** Siegenthaler, Peter**Address:** 333 Burma Road**City:** Oakland, CA 94607**Report No:** WIR-019473**Date Inspected:** 24-Jan-2011**Project Name:** SAS Superstructure**OSM Arrival Time:** 630**Prime Contractor:** American Bridge/Fluor Enterprises, a JV**OSM Departure Time:** 1500**Contractor:** American Bridge/Fluor Enterprises, a JV**Location:** Job Site**CWI Name:** See below**CWI Present:** Yes No**Inspected CWI report:** Yes No N/A**Rod Oven in Use:** Yes No N/A**Electrode to specification:** Yes No N/A**Weld Procedures Followed:** Yes No N/A**Qualified Welders:** Yes No N/A**Verified Joint Fit-up:** Yes No N/A**Approved Drawings:** Yes No N/A**Approved WPS:** Yes No N/A**Delayed / Cancelled:** Yes No N/A**Bridge No:** 34-0006**Component:** SAS OBG**Summary of Items Observed:**

The Quality Assurance (QA) Inspector, Rick Bettencourt was on site at the job site between the times noted above. The QA Inspector was on site to randomly observe the in process welding and inspection of the weld joints identified as 4W-pp25-W3-1,2,3,4, 3W-pp22-W4-1, Jacking Frame to Sadd

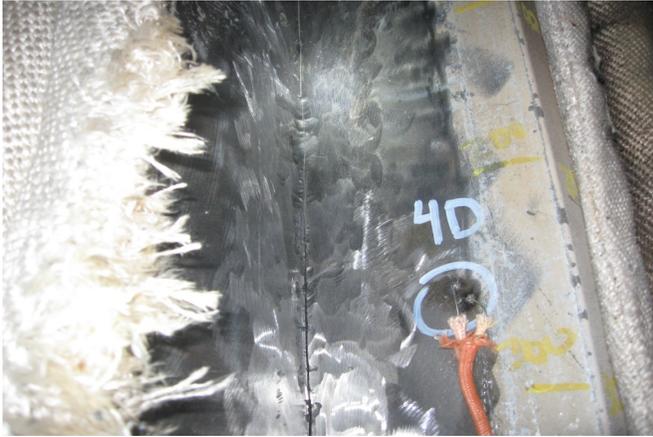
It was previously discovered the East fillet weld had cracked approximately 550mm near the toe of the weld. The QA Inspector noted the cracked area of the weld joint was excavated on Friday 1-21-11 in an attempt to keep the cracked area of weld from propagating. The QA Inspector observed some base material gouges were observed and appeared to be a result of the carbon arc gouging during the removal of the weld joint (see below). The QA Inspector noted the base material gouged were in the weld zone and would essentially be repaired when the weld joint is re-welded. After the ABF apprentice completed the grinding the QA Inspector observed ABF personnel begin installing the thermo couplers in preparation of production welding. The QA Inspector noted no additional work was performed at the above identified location on this date. The QA Inspector wrote and submitted an Incident Report due to the fact, ABF proceeded with removing the entire fillet weld without receiving prior engineering approval from the department.
