DEPARTMENT OF TRANSPORTATION

Quality Assurance and Source Inspection

Contract #: 04-0120F4Cty: SF/ALA Rte: 80 PM: 13.2/13.9File #: 99.28**WELDING INSPECTION REPORT****Resident Engineer:** Siegenthaler, Peter**Address:** 333 Burma Road**City:** Oakland, CA 94607**Report No:** WIR-019497**Date Inspected:** 23-Jan-2011**Project Name:** SAS Superstructure**OSM Arrival Time:** 700**Prime Contractor:** American Bridge/Fluor Enterprises, a JV**OSM Departure Time:** 1900**Contractor:** Zhenhua Port Machinery Company, Ltd (ZPMC) Chanxing Island**Location:** Shanghai, China**CWI Name:** Mr. Qui Wen**CWI Present:** Yes No**Inspected CWI report:** Yes No N/A**Rod Oven in Use:** Yes No N/A**Electrode to specification:** Yes No N/A**Weld Procedures Followed:** Yes No N/A**Qualified Welders:** Yes No N/A**Verified Joint Fit-up:** Yes No N/A**Approved Drawings:** Yes No N/A**Approved WPS:** Yes No N/A**Delayed / Cancelled:** Yes No N/A**Bridge No:** 34-0006**Component:** OBG Segment**Summary of Items Observed:**

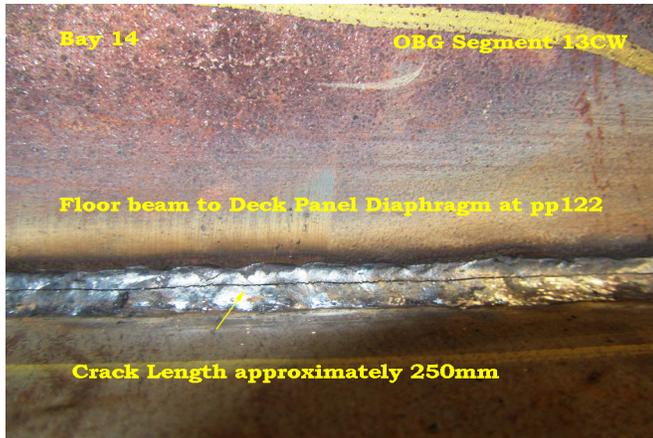
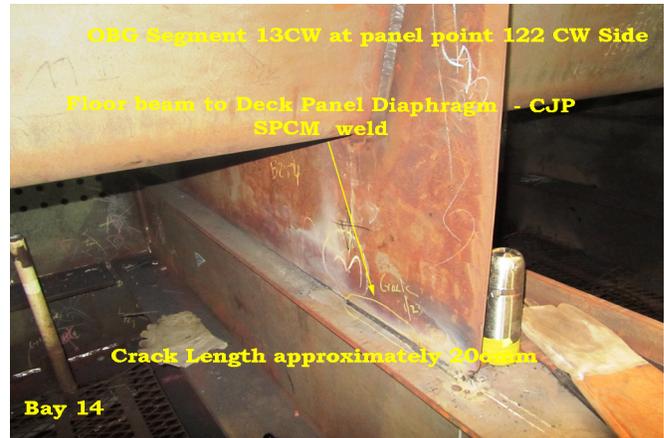
Description of Incident: During the Quality Assurance random visual inspection of welds located on Segment 13CW at panel point 122.5, this Quality Assurance Inspector (QA) observed that ZMPC personnel performed welding on Floor beam to deck panel diaphragm weld, during this heat straightening at panel point 123 the Floor Beam Flange to Deck Panel Diaphragm Tack Welds are get cracks after that ZPMC personnel performed welding over same place. Second time also same place tack weld are crack though out weld length. It happens at pp122.5 and 122 counter weight side OBG Segment 13CW. This weld is a Complete Joint Penetration (CJP) weld joining the floor beam flange to deck panel diaphragm. The floor beam flange to deck panel diaphragm weld is identified as SPCM. This weld is designated as Seismic Performance Critical Member (SPCM). OBG segment 13CW is located West Side of Bay 14 area. The ZPMC QC is identified as Mr. Li Ming Yang. QA inform to ZPMC that prior to the repair welding, to prepare CWR and ensure with VT and MT all defect have been removed. See the attaché picture.
