**DEPARTMENT OF TRANSPORTATION**

Contract #: 04-0120F4Cty: SF/ALA Rte: 80 PM: 13.2/13.9File #: 99.28**WELDING INSPECTION REPORT****Resident Engineer:** Siegenthaler, Peter**Address:** 333 Burma Road**City:** Oakland, CA 94607**Report No:** WIR-019499**Date Inspected:** 21-Jan-2011**Project Name:** SAS Superstructure**OSM Arrival Time:** 700**Prime Contractor:** American Bridge/Fluor Enterprises, a JV**OSM Departure Time:** 1900**Contractor:** Zhenhua Port Machinery Company, Ltd (ZPMC) Chanxing Island**Location:** Shanghai, China**CWI Name:** Mr. Qui Wen**CWI Present:** Yes No**Inspected CWI report:** Yes No N/A**Rod Oven in Use:** Yes No N/A**Electrode to specification:** Yes No N/A**Weld Procedures Followed:** Yes No N/A**Qualified Welders:** Yes No N/A**Verified Joint Fit-up:** Yes No N/A**Approved Drawings:** Yes No N/A**Approved WPS:** Yes No N/A**Delayed / Cancelled:** Yes No N/A**Bridge No:** 34-0006**Component:** OBG Segment**Summary of Items Observed:**

## WELDING INSPECTION REPORT

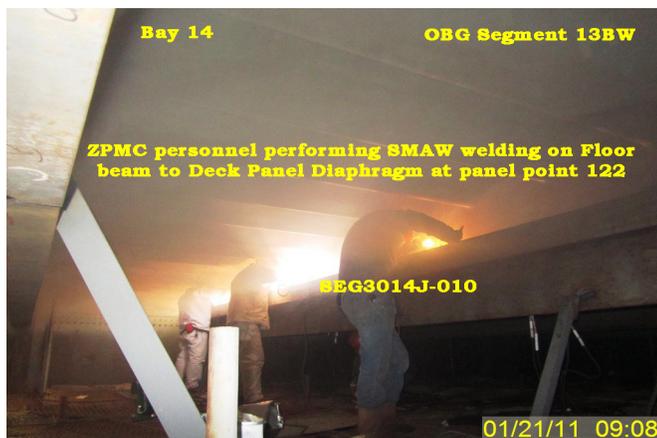
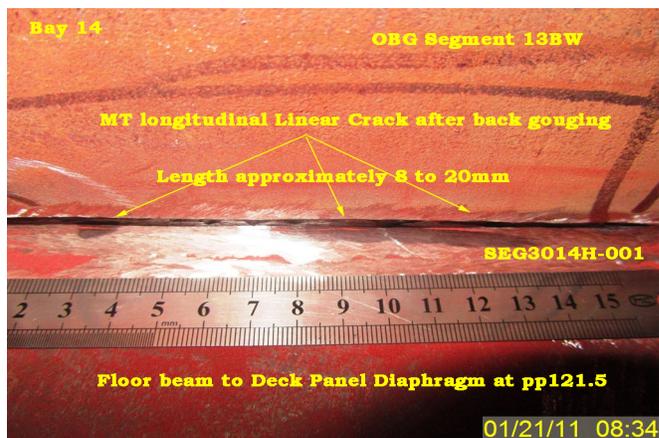
Description of Incident: During the Quality Assurance random visual inspection of welds located on OBG Segment 13BW at panel point 121.5, this Quality Assurance Inspector (QA) observed three (3) Linear Longitudinal Indications measuring approximately 8 to 20mm in lengths. The indications were discovered visually and confirmed by Magnetic particle Testing (MT) by ZPMC MT personnel. ZPMC performed MT on this weld after back gouging as per the contract documents. The indications are clearly marked on the material near the weld for further repair. The weld number is identified as SEG3014H-001. The panel point is identified as a PP121.5. This weld is a CJP weld joining the Floor beam Flange to Deck Panel Diaphragm. The Floor beam Flange to Deck Panel Diaphragm weld is identified as SPCM. This weld is designated as Seismic Performance Critical Member (SPCM). The cracks are completely removed and re-welded as per required contract document WPS. For further information, please see the attached pictures
