DEPARTMENT OF TRANSPORTATION

Quality Assurance and Source Inspection

Contract #: 04-0120F4Cty: SF/ALA Rte: 80 PM: 13.2/13.9File #: 99.28**WELDING INSPECTION REPORT****Resident Engineer:** Siegenthaler, Peter**Address:** 333 Burma Road**City:** Oakland, CA 94607**Report No:** WIR-019500**Date Inspected:** 20-Jan-2011**Project Name:** SAS Superstructure**OSM Arrival Time:** 700**Prime Contractor:** American Bridge/Fluor Enterprises, a JV**OSM Departure Time:** 1900**Contractor:** Zhenhua Port Machinery Company, Ltd (ZPMC) Chanxing Island**Location:** Shanghai, China**CWI Name:** Mr. Qui Wen**CWI Present:** Yes No**Inspected CWI report:** Yes No N/A**Rod Oven in Use:** Yes No N/A**Electrode to specification:** Yes No N/A**Weld Procedures Followed:** Yes No N/A**Qualified Welders:** Yes No N/A**Verified Joint Fit-up:** Yes No N/A**Approved Drawings:** Yes No N/A**Approved WPS:** Yes No N/A**Delayed / Cancelled:** Yes No N/A**Bridge No:** 34-0006**Component:** OBG Segment**Summary of Items Observed:**

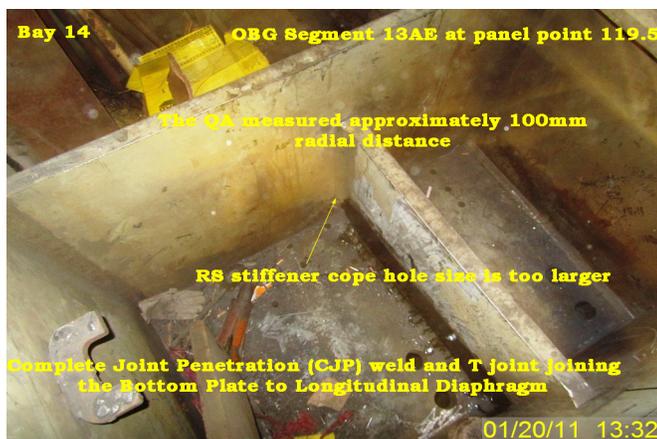
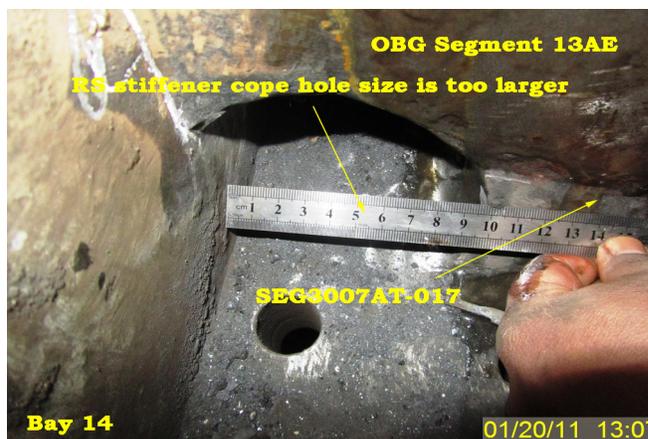
Description of Incident: During the Quality Assurance random visual inspection of welds located on OBG Segment 13AE at panel point 119.5, this Quality Assurance Inspector (QA) observed that RS stiffener cope hole size is too larger as per the shop drawing. The QA measured approximately 100mm radial distance, but the shop drawing mention 75mm radial distance. This weld is a Complete Joint Penetration (CJP) weld and T joint joining the Bottom Plate to Longitudinal Diaphragm. The Bottom Plate to Longitudinal Diaphragm weld is identified as SPCM. This weld is designated as Seismic Performance Critical Member (SPCM). The weld is identified as SEG3007AT-017. The OBG segment 13AE is located East Side of Bay 14 area. The ZPMC QC is identified as Mr. Geng Wei. QA inform to ZPMC QC that prior to the repair welding, to prepare WWR and ensure the cope hole are comply with as per shop drawing. See the attaché picture.
