DEPARTMENT OF TRANSPORTATION

Contract #: 04-0120F4Cty: SF/ALA Rte: 80 PM: 13.2/13.9File #: 69.28**WELDING INSPECTION REPORT****Resident Engineer:** Siegenthaler, Peter**Address:** 333 Burma Road**City:** Oakland, CA 94607**Report No:** WIR-019506**Date Inspected:** 26-Jan-2011**Project Name:** SAS Superstructure**OSM Arrival Time:** 700**Prime Contractor:** American Bridge/Fluor Enterprises, a JV**OSM Departure Time:** 1900**Contractor:** Zhenhua Port Machinery Company, Ltd (ZPMC), Changxing Island **Location:** Shanghai, China**CWI Name:** Cheng Xi/Lv Li Qing**CWI Present:** Yes No**Inspected CWI report:** Yes No N/A**Rod Oven in Use:** Yes No N/A**Electrode to specification:** Yes No N/A**Weld Procedures Followed:** Yes No N/A**Qualified Welders:** Yes No N/A**Verified Joint Fit-up:** Yes No N/A**Approved Drawings:** Yes No N/A**Approved WPS:** Yes No N/A**Delayed / Cancelled:** Yes No N/A**Bridge No:** 34-0006**Component:** OBG**Summary of Items Observed:**

WELDING INSPECTION REPORT

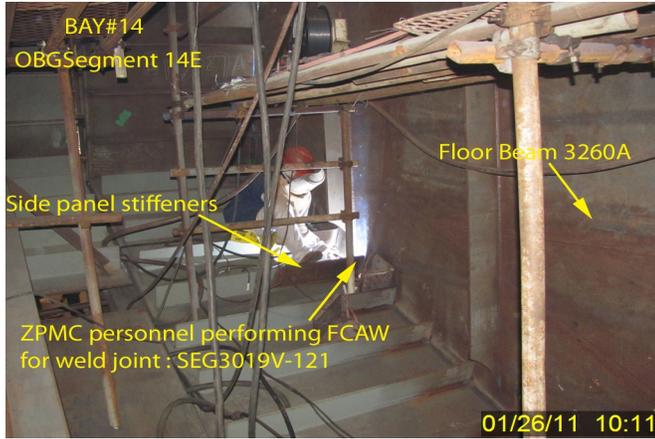
This QA Inspector observed the following work in progress:
FCAW in the 3G position for the OBG Segment 14E Floor Beam to Side panel stiffener. The weld joint was designated as: SEG3019V-121. The welder is identified as #068501. ZPMC QC is identified as Mr.Guo shi hui . The welding variables recorded by QC appear to comply with WPS-B-T-2233-ESAB.Please see the attached picture.

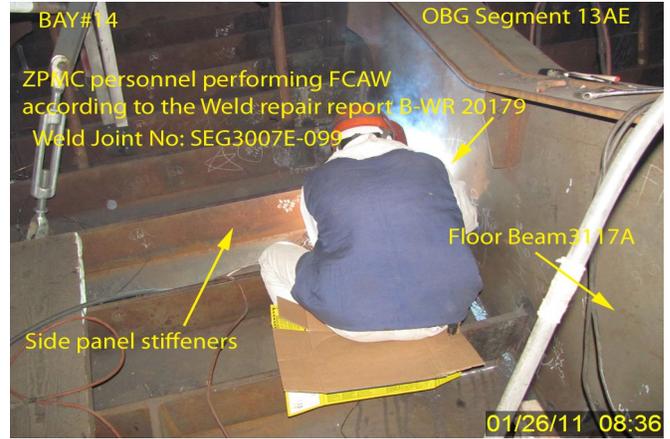
This QA inspector observed the following work in progress:
FCAW welding of weld joint no: SEG3007E-099 located on OBG Segment 13AE Floor Beam to Side panel stiffener. Welder is identified as #044795. ZPMC CWI is identified as Mr. Lv Li Qing. Welding was performed according to the weld repair report B-WR 20179.The welding variables recorded by QC appeared to comply with the WPS-345-FCAW-3G(3F)-ESAB-Repair. Please see the attached picture.
