Contract #: 04-0120F4Cty: SF/ALA Rte: 80 PM: 13.2/13.9File #: 69.28**WELDING INSPECTION REPORT****Resident Engineer:** Siegenthaler, Peter**Address:** 333 Burma Road**City:** Oakland, CA 94607**Report No:** WIR-019519**Date Inspected:** 23-Jan-2011**Project Name:** SAS Superstructure**OSM Arrival Time:** 700**Prime Contractor:** American Bridge/Fluor Enterprises, a JV**OSM Departure Time:** 1900**Contractor:** Zhenhua Port Machinery Company, Ltd (ZPMC), Changxing Island **Location:** Shanghai, China**CWI Name:** An Qing Xiang**CWI Present:** Yes No**Inspected CWI report:** Yes No N/A**Rod Oven in Use:** Yes No N/A**Electrode to specification:** Yes No N/A**Weld Procedures Followed:** Yes No N/A**Qualified Welders:** Yes No N/A**Verified Joint Fit-up:** Yes No N/A**Approved Drawings:** Yes No N/A**Approved WPS:** Yes No N/A**Delayed / Cancelled:** Yes No N/A**Bridge No:** 34-0006**Component:** OBG**Summary of Items Observed:**

WELDING INSPECTION REPORT

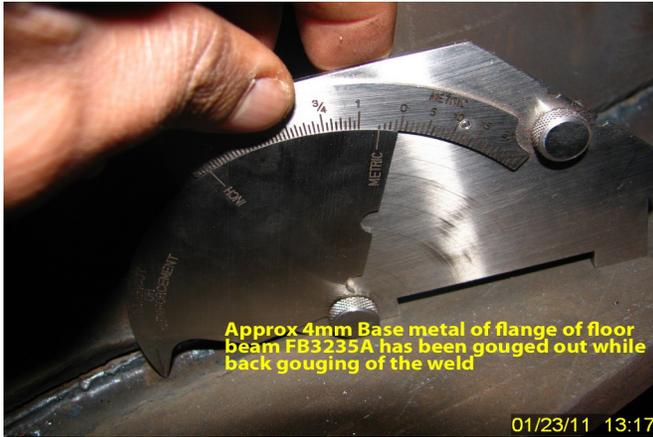
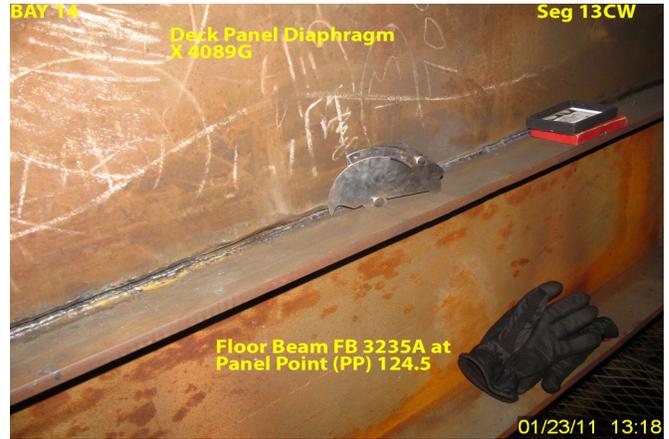
During random in process inspection this QA inspector observed that the weld joining the deck panel diaphragm plate X 4089G to the flange of Floor Beam (FB) 3235A at panel point PP 124.5 of seg 13CW observed as cracked. The base metal of flange of FB 3235A has been gouged out approx 4mm during bach gouging by Air Carbon Arc Gouging. This issue has been discussed with ZPMC CWI Mr. Li Ming Yang and CT lead QA. Mr. Li Ming Yang

informed this QA that this issue would be corrected in manner compliant with contract documents. Attached photograph provide additional details.
