DEPARTMENT OF TRANSPORTATION

Contract #: 04-0120F4Cty: SF/ALA Rte: 80 PM: 13.2/13.9File #: 69.28**WELDING INSPECTION REPORT****Resident Engineer:** Siegenthaler, Peter**Address:** 333 Burma Road**City:** Oakland, CA 94607**Report No:** WIR-019532**Date Inspected:** 26-Jan-2011**Project Name:** SAS Superstructure**OSM Arrival Time:** 700**Prime Contractor:** American Bridge/Fluor Enterprises, a JV**OSM Departure Time:** 1900**Contractor:** Zhenhua Port Machinery Company, Ltd (ZPMC), Changxing Island **Location:** Shanghai, China**CWI Name:** Qiu Wen.**CWI Present:** Yes No**Inspected CWI report:** Yes No N/A**Rod Oven in Use:** Yes No N/A**Electrode to specification:** Yes No N/A**Weld Procedures Followed:** Yes No N/A**Qualified Welders:** Yes No N/A**Verified Joint Fit-up:** Yes No N/A**Approved Drawings:** Yes No N/A**Approved WPS:** Yes No N/A**Delayed / Cancelled:** Yes No N/A**Bridge No:** 34-0006**Component:** OBG components.**Summary of Items Observed:**

WELDING INSPECTION REPORT

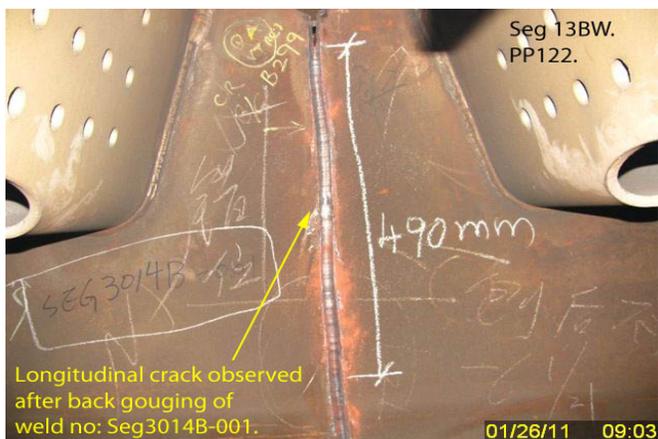
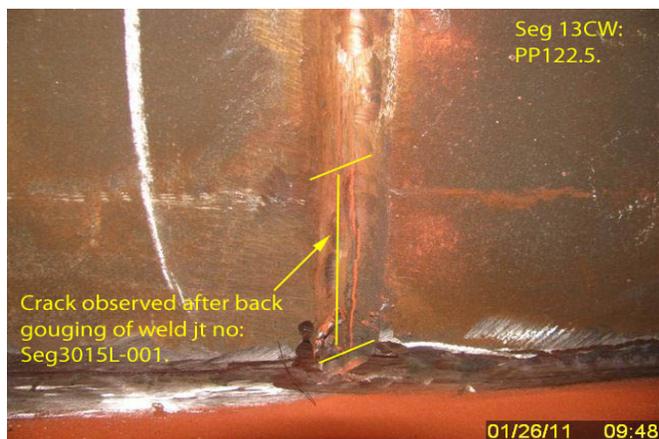
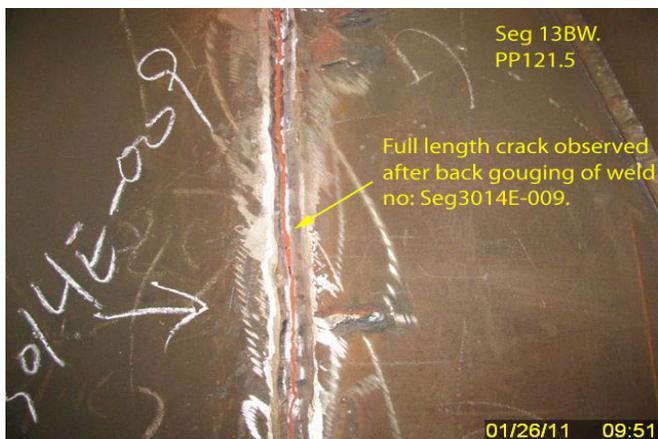
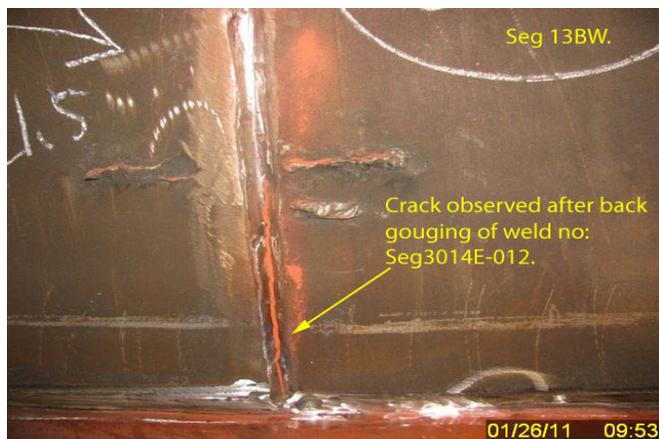
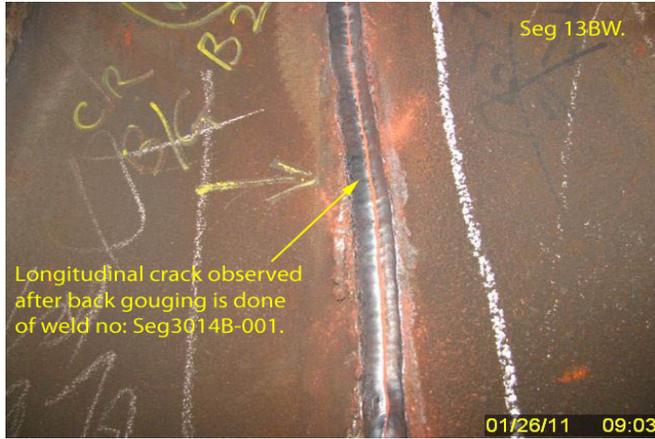
During random inprocess visual inspection of DP Diaphragm splice welds, this QA Inspector observed that some of the splice joints after back gouging were found to have cracks. This QA Inspector informed this to ZPMC CWI, identified as Li Ming Yang. ZPMC QC agreed that welding of these welds will be done after having approval of CWR. See attached photos for further information.
