**DEPARTMENT OF TRANSPORTATION**

Contract #: 04-0120F4Cty: SF/ALA Rte: 80 PM: 13.2/13.9File #: 99.28**WELDING INSPECTION REPORT****Resident Engineer:** Siegenthaler, Peter**Address:** 333 Burma Road**City:** Oakland, CA 94607**Report No:** WIR-019625**Date Inspected:** 02-Jan-2011**Project Name:** SAS Superstructure**OSM Arrival Time:** 700**Prime Contractor:** American Bridge/Fluor Enterprises, a JV**OSM Departure Time:** 1900**Contractor:** Zhenhua Port Machinery Company, Ltd (ZPMC) Chanxing Island**Location:** Shanghai, China**CWI Name:** Mr. SHI LIE**CWI Present:** Yes No**Inspected CWI report:** Yes No N/A**Rod Oven in Use:** Yes No N/A**Electrode to specification:** Yes No N/A**Weld Procedures Followed:** Yes No N/A**Qualified Welders:** Yes No N/A**Verified Joint Fit-up:** Yes No N/A**Approved Drawings:** Yes No N/A**Approved WPS:** Yes No N/A**Delayed / Cancelled:** Yes No N/A**Bridge No:** 34-0006**Component:** OBG Segment**Summary of Items Observed:**

Orthotropic Box Girder (OBG) at Trial Assembly Area:

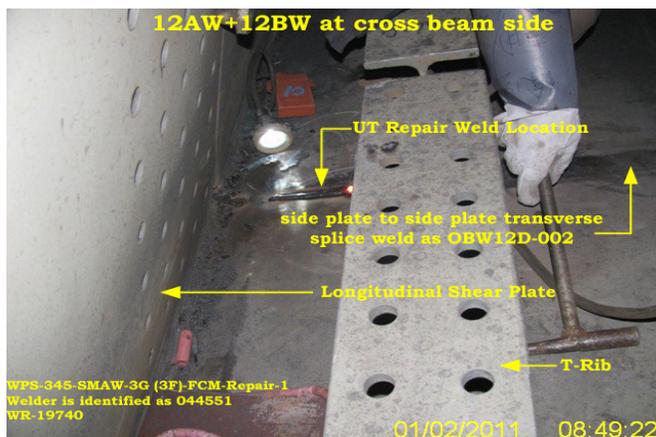
ZPMC welding personnel performing Shielded Metal Arc Welding (SMAW) of Repair weld for the side plate to side plate transverse splice weld joint located on 12AW+12BW at cross beam side. The weld is designated as OBW12D-002. The welder is identified as 044551. ZPMC QC Mr. ZHOU PENG was onsite monitoring the welding variables. The inprocess SMAW appears to be progressing in compliance with WPS-345-SMAW-3G (3F)-FCM-Repair-1. The weld repair report number is named as WR-19740. Further weld detail mention in attached picture.
