DEPARTMENT OF TRANSPORTATION

Contract #: 04-0120F4Cty: SF/ALA Rte: 80 PM: 13.2/13.9File #: 99.28**WELDING INSPECTION REPORT****Resident Engineer:** Siegenthaler, Peter**Address:** 333 Burma Road**City:** Oakland, CA 94607**Report No:** WIR-019628**Date Inspected:** 28-Jan-2011**Project Name:** SAS Superstructure**OSM Arrival Time:** 700**Prime Contractor:** American Bridge/Fluor Enterprises, a JV**OSM Departure Time:** 1900**Contractor:** Zhenhua Port Machinery Company, Ltd (ZPMC) Chanxing Island**Location:** Shanghai, China**CWI Name:** Mr. SHAU JIAN YUAN**CWI Present:** Yes No**Inspected CWI report:** Yes No N/A**Rod Oven in Use:** Yes No N/A**Electrode to specification:** Yes No N/A**Weld Procedures Followed:** Yes No N/A**Qualified Welders:** Yes No N/A**Verified Joint Fit-up:** Yes No N/A**Approved Drawings:** Yes No N/A**Approved WPS:** Yes No N/A**Delayed / Cancelled:** Yes No N/A**Bridge No:** 34-0006**Component:** OBG Segment**Summary of Items Observed:**

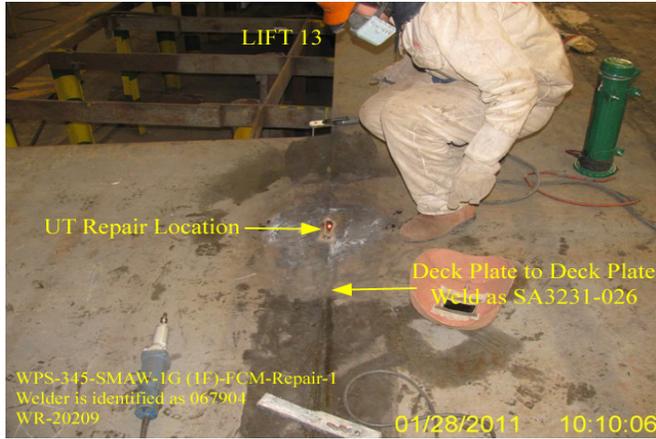
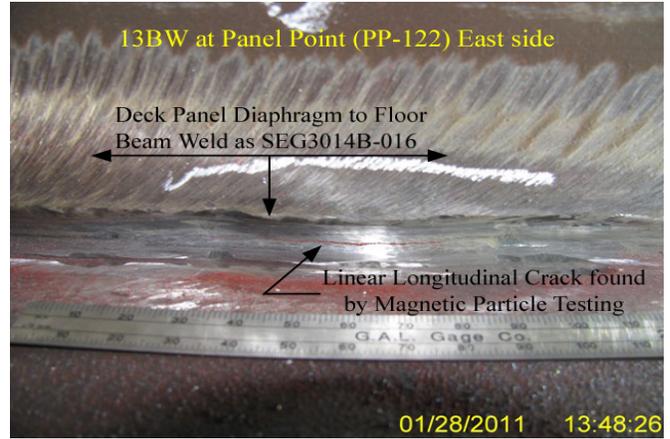
ZPMC Quality Control (QC) personnel performing Magnetic Particle Testing (MT) for back gouged weld of Complete Joint Penetration (CJP) welds joining the deck panel diaphragm to floor beam weld joint located on 13BW at Panel Point (PP-122) East side. The weld is designated as SEG3014B-016. After back gouging & grinding linear longitudinal crack found by Magnetic Particle Testing (MT) & measured 40mm in length of gouged area. The information passed over the ABF QA Mr. CAO HAI ZHOU for to perform the magnetic particle testing after grind the full length of weld & repair the weld. Further weld detail mention in attached picture.
