DEPARTMENT OF TRANSPORTATION

Contract #: 04-0120F4Cty: SF/ALA Rte: 80 PM: 13.2/13.9File #: 69.28**WELDING INSPECTION REPORT****Resident Engineer:** Siegenthaler, Peter**Address:** 333 Burma Road**City:** Oakland, CA 94607**Report No:** WIR-019649**Date Inspected:** 30-Dec-2010**Project Name:** SAS Superstructure**OSM Arrival Time:** 700**Prime Contractor:** American Bridge/Fluor Enterprises, a JV**OSM Departure Time:** 1900**Contractor:** Zhenhua Port Machinery Company, Ltd (ZPMC), Changxing Island **Location:** Shanghai, China

Bridge No: 34-0006**Component:** OBG**Summary of Items Observed:**

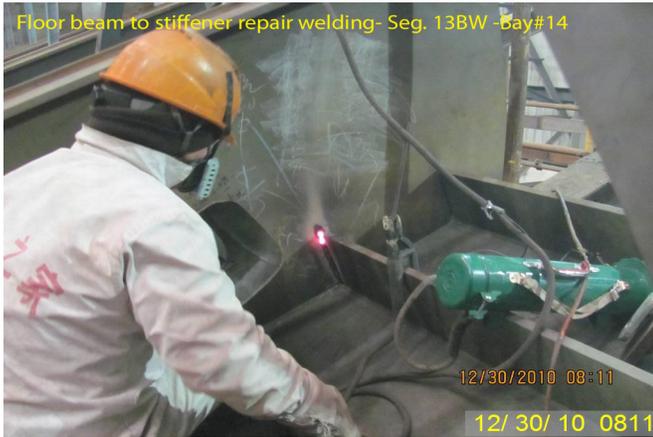
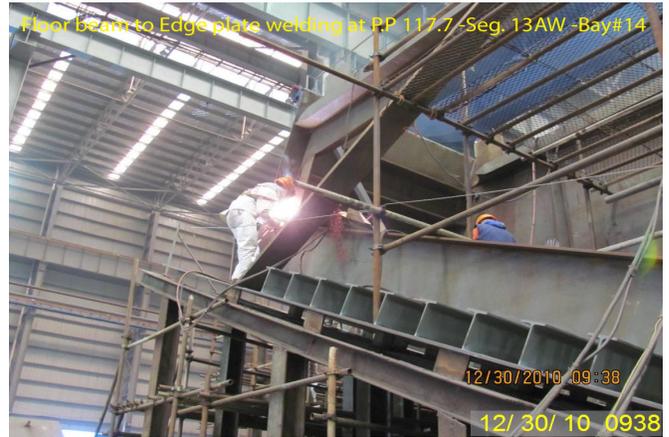
For further information see below pictures:-

Unless otherwise noted, all work observed on this date appeared to be in general compliance with the applicable contract documents.
