Contract #: 04-0120F4Cty: SF/ALA Rte: 80 PM: 13.2/13.9File #: 69.28**WELDING INSPECTION REPORT****Resident Engineer:** Siegenthaler, Peter**Address:** 333 Burma Road**City:** Oakland, CA 94607**Report No:** WIR-019650**Date Inspected:** 01-Jan-2011**Project Name:** SAS Superstructure**OSM Arrival Time:** 700**Prime Contractor:** American Bridge/Fluor Enterprises, a JV**OSM Departure Time:** 1900**Contractor:** Zhenhua Port Machinery Company, Ltd (ZPMC), Changxing Island **Location:** Shanghai, China

Orthotropic Box Girder (OBG)

WELDING INSPECTION REPORT

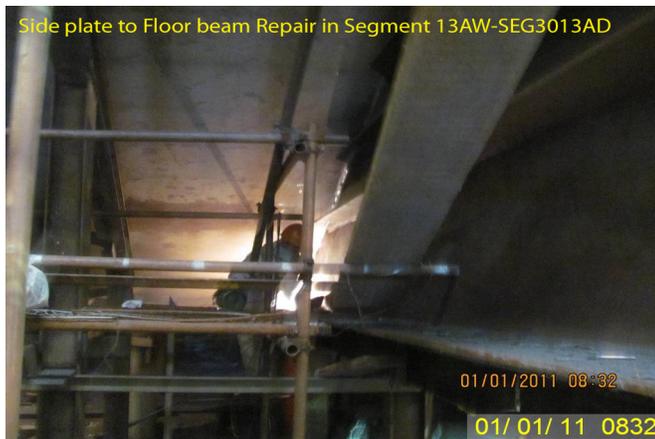
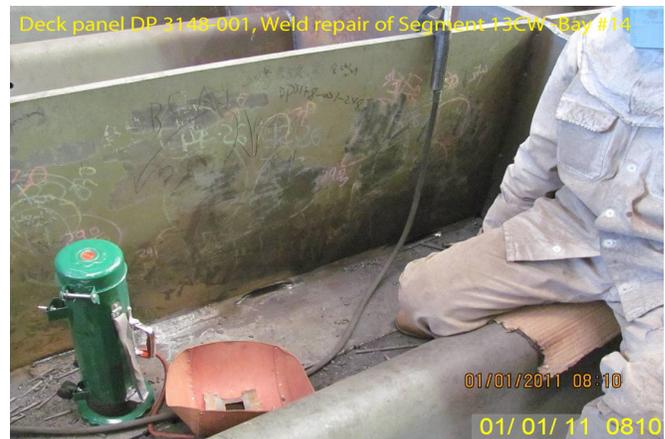
For further information see below pictures:-

Unless otherwise noted, all work observed on this date appeared to be in general compliance with the applicable contract documents.
