**DEPARTMENT OF TRANSPORTATION**

Contract #: 04-0120F4Cty: SF/ALA Rte: 80 PM: 13.2/13.9File #: 69.28**WELDING INSPECTION REPORT****Resident Engineer:** Siegenthaler, Peter**Address:** 333 Burma Road**City:** Oakland, CA 94607**Report No:** WIR-019651**Date Inspected:** 02-Jan-2011**Project Name:** SAS Superstructure**OSM Arrival Time:** 700**Prime Contractor:** American Bridge/Fluor Enterprises, a JV**OSM Departure Time:** 1900**Contractor:** Zhenhua Port Machinery Company, Ltd (ZPMC), Changxing Island **Location:** Shanghai, China

**Bridge No:** 34-0006**Component:** OBG**Summary of Items Observed:**

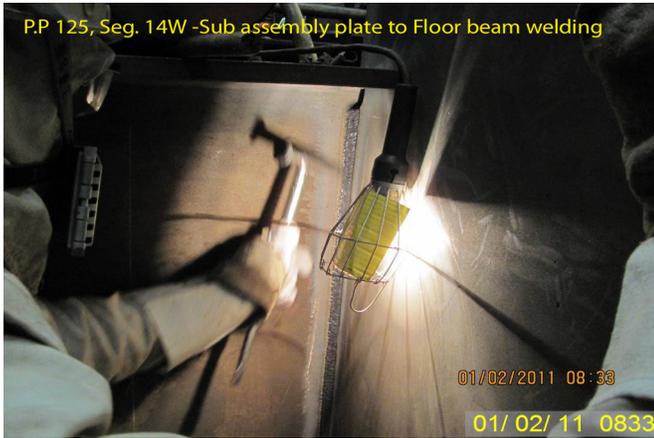
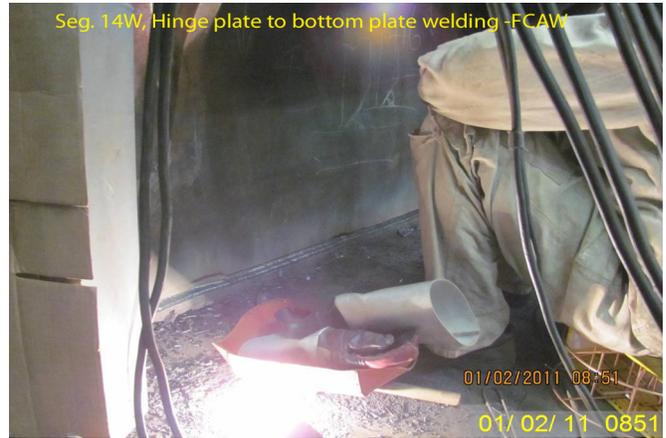
For further information see below pictures:-

Unless otherwise noted, all work observed on this date appeared to be in general compliance with the applicable contract documents.
