DEPARTMENT OF TRANSPORTATION

Contract #: 04-0120F4Cty: SF/ALA Rte: 80 PM: 13.2/13.9File #: 69.28**WELDING INSPECTION REPORT****Resident Engineer:** Siegenthaler, Peter**Address:** 333 Burma Road**City:** Oakland, CA 94607**Report No:** WIR-019652**Date Inspected:** 03-Jan-2011**Project Name:** SAS Superstructure**OSM Arrival Time:** 700**Prime Contractor:** American Bridge/Fluor Enterprises, a JV**OSM Departure Time:** 1900**Contractor:** Zhenhua Port Machinery Company, Ltd (ZPMC), Changxing Island **Location:** Shanghai, China

Bridge No: 34-0006**Component:** OBG**Summary of Items Observed:**

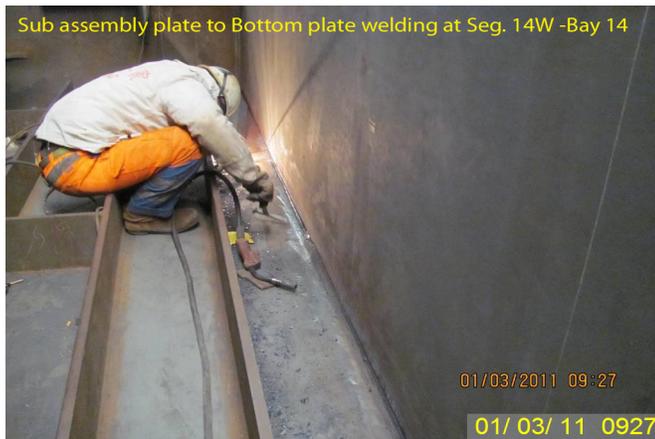
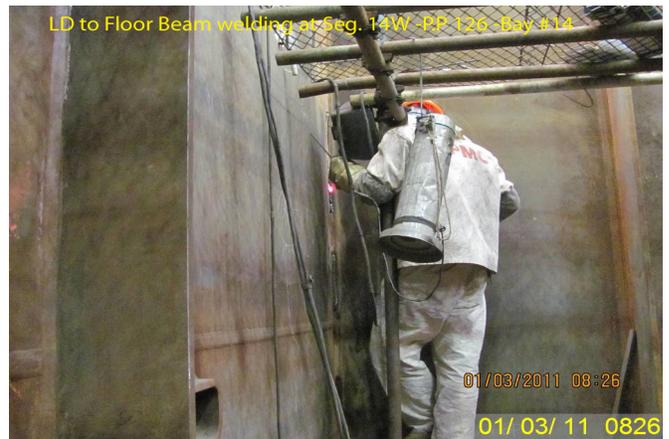
For further information see below pictures:-

Unless otherwise noted, all work observed on this date appeared to be in general compliance with the applicable contract documents.
