DEPARTMENT OF TRANSPORTATION

Contract #: 04-0120F4Cty: SF/ALA Rte: 80 PM: 13.2/13.9File #: 69.28**WELDING INSPECTION REPORT****Resident Engineer:** Siegenthaler, Peter**Address:** 333 Burma Road**City:** Oakland, CA 94607**Report No:** WIR-019666**Date Inspected:** 11-Jan-2011**Project Name:** SAS Superstructure**OSM Arrival Time:** 700**Prime Contractor:** American Bridge/Fluor Enterprises, a JV**OSM Departure Time:** 1900**Contractor:** Zhenhua Port Machinery Company, Ltd (ZPMC), Changxing Island **Location:** Shanghai, China**CWI Name:** Mr. Zhu Zhong Hai.**CWI Present:** Yes No**Inspected CWI report:** Yes No N/A**Rod Oven in Use:** Yes No N/A**Electrode to specification:** Yes No N/A**Weld Procedures Followed:** Yes No N/A**Qualified Welders:** Yes No N/A**Verified Joint Fit-up:** Yes No N/A**Approved Drawings:** Yes No N/A**Approved WPS:** Yes No N/A**Delayed / Cancelled:** Yes No N/A**Bridge No:** 34-0006**Component:** Tower and Orthotropic Box Girder (OBG)**Summary of Items Observed:**

WELDING INSPECTION REPORT

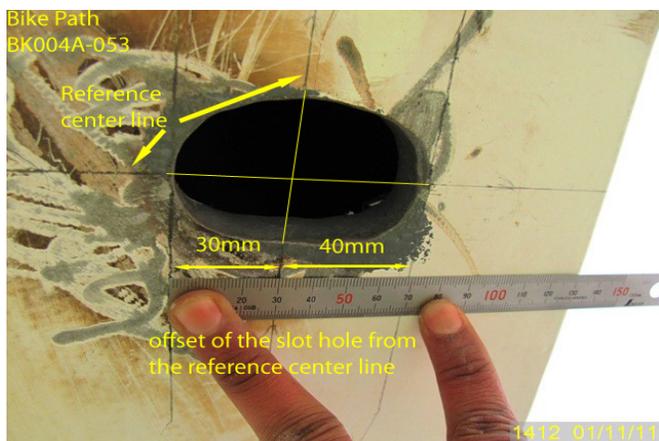
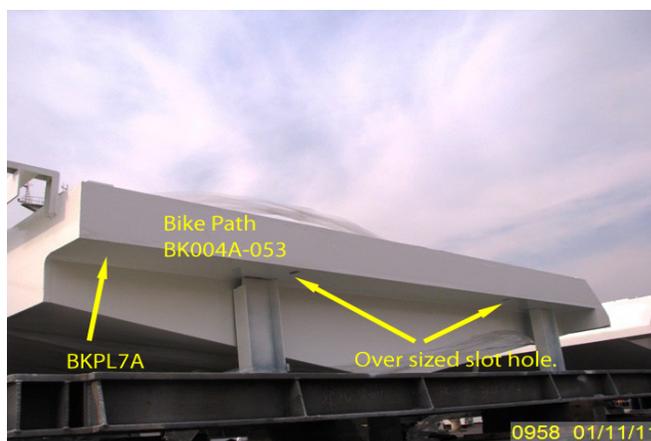
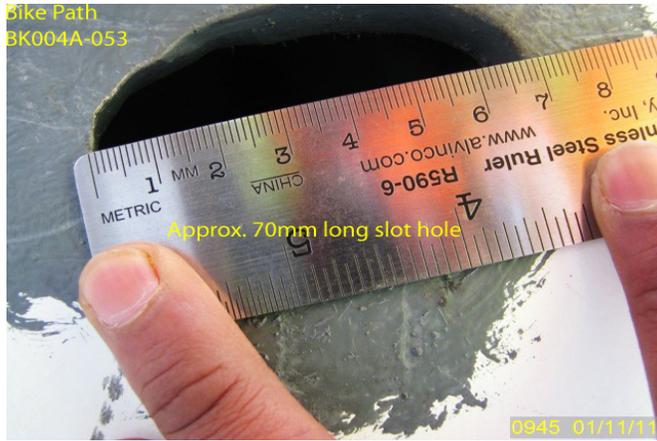
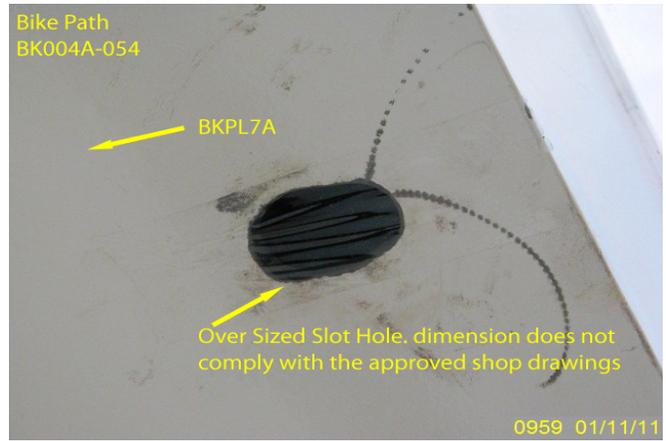
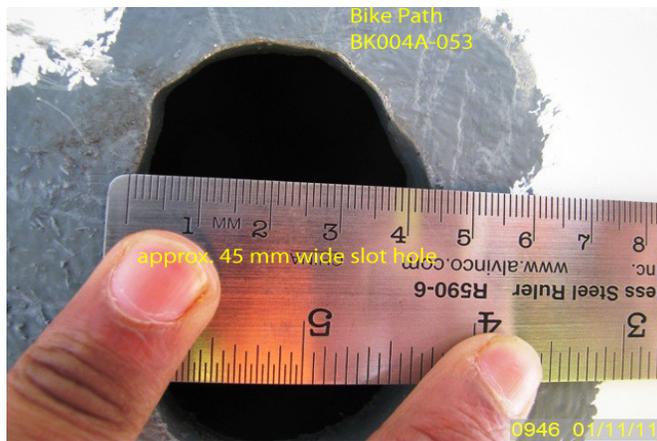
During Quality Assurance (QA) dimensional check of the slotted hole on the bearing plate of the bike path, This QA inspector discovered the following issues:

QA Inspector observed the oversized slotted holes on the bearing plate (BKPL7A for BK4A and BKPL14A for BK6A) of the bike paths. The affected Bike Path components are identified as; BK004A-001, BK004A-003, BK004A-004, BK004A-005, BK004A-008, BK004A-009, BK004A-010, BK004A-012, BK004A-017, BK004A-019, BK004A-020, BK004A-021, BK004A-026, BK004A-053, BK004A-054, BK004A-056, BK006A-002. The slotted hole dimensions measured approx. 68~72 mm long and 40~45mm wide. The measured dimensions do not comply with the approved shop drawings. This QA inspector also observed the miss located slotted hole from its reference center line. The final Green Tag for the above mentioned bike paths were submitted for QA review. Above mentioned bike paths will be in the shipment#6. For more information see attached picture.
