**DEPARTMENT OF TRANSPORTATION**

Contract #: 04-0120F4Cty: SF/ALA Rte: 80 PM: 13.2/13.9File #: 69.28**WELDING INSPECTION REPORT****Resident Engineer:** Siegenthaler, Peter**Address:** 333 Burma Road**City:** Oakland, CA 94607**Report No:** WIR-019672**Date Inspected:** 29-Dec-2010**Project Name:** SAS Superstructure**OSM Arrival Time:** 700**Prime Contractor:** American Bridge/Fluor Enterprises, a JV**OSM Departure Time:** 1900**Contractor:** Zhenhua Port Machinery Company, Ltd (ZPMC), Changxing Island **Location:** Shanghai, China**CWI Name:** Zhu Feng**CWI Present:** Yes No**Inspected CWI report:** Yes No N/A**Rod Oven in Use:** Yes No N/A**Electrode to specification:** Yes No N/A**Weld Procedures Followed:** Yes No N/A**Qualified Welders:** Yes No N/A**Verified Joint Fit-up:** Yes No N/A**Approved Drawings:** Yes No N/A**Approved WPS:** Yes No N/A**Delayed / Cancelled:** Yes No N/A**Bridge No:** 34-0006**Component:** TOWER & OBG Components**Summary of Items Observed:**

**NORTH TOWER LIFT-4, REPAIR AREAS AFTER BLASTING AND PAINTING (EXTERNAL)**

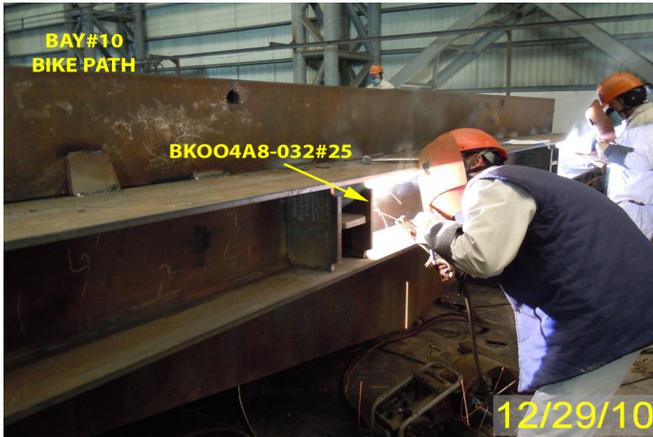
Weld joint # 25 located on Bike Path BK004A8 – 032. Welder is identified as 052493. ZPMC Quality Control (QC) Inspector is identified as Yu Zhi Lai. The welding variables recorded by QC appeared to comply with the WPS – B – P – 2113. (See attached photo)

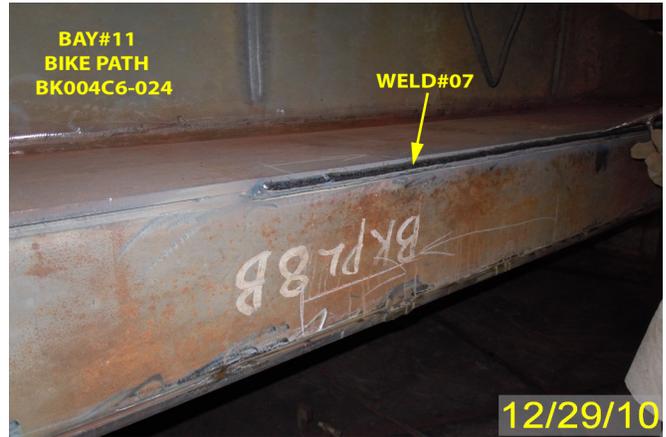
Weld joint # 07 located on Bike Path BK004C6 – 024. Welder is identified as 205649. ZPMC Quality Control (QC) Inspector is identified as Wang Chung Xin. The welding variables recorded by QC appeared to comply with the WPS – B – T – 2232 – ESAB. (See attached photo)
