DEPARTMENT OF TRANSPORTATION

Contract #: 04-0120F4Cty: SF/ALA Rte: 80 PM: 13.2/13.9File #: 69.28**WELDING INSPECTION REPORT****Resident Engineer:** Siegenthaler, Peter**Address:** 333 Burma Road**City:** Oakland, CA 94607**Report No:** WIR-019675**Date Inspected:** 29-Jan-2011**Project Name:** SAS Superstructure**OSM Arrival Time:** 1500**Prime Contractor:** American Bridge/Fluor Enterprises, a JV**OSM Departure Time:** 300**Contractor:** Zhenhua Port Machinery Company, Ltd (ZPMC), Changxing Island **Location:** Shanghai, China

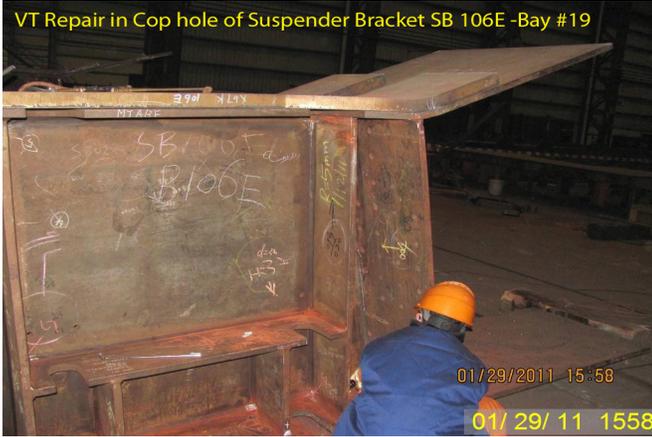
For further information see below pictures:-
