**DEPARTMENT OF TRANSPORTATION**

Contract #: 04-0120F4Cty: SF/ALA Rte: 80 PM: 13.2/13.9File #: 69.28**WELDING INSPECTION REPORT****Resident Engineer:** Siegenthaler, Peter**Address:** 333 Burma Road**City:** Oakland, CA 94607**Report No:** WIR-019689**Date Inspected:** 20-Jan-2011**Project Name:** SAS Superstructure**OSM Arrival Time:** 700**Prime Contractor:** American Bridge/Fluor Enterprises, a JV**OSM Departure Time:** 1900**Contractor:** Zhenhua Port Machinery Company, Ltd (ZPMC), Changxing Island **Location:** Shanghai, China**CWI Name:** Mr. Xu Le Feng.**CWI Present:** Yes No**Inspected CWI report:** Yes No N/A**Rod Oven in Use:** Yes No N/A**Electrode to specification:** Yes No N/A**Weld Procedures Followed:** Yes No N/A**Qualified Welders:** Yes No N/A**Verified Joint Fit-up:** Yes No N/A**Approved Drawings:** Yes No N/A**Approved WPS:** Yes No N/A**Delayed / Cancelled:** Yes No N/A**Bridge No:** 34-0006**Component:** Tower and Orthotropic Box Girder (OBG)**Summary of Items Observed:**

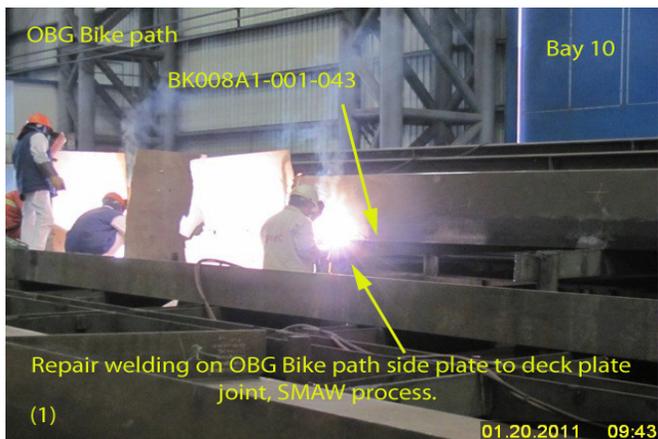
This QA Inspector observed ZPMC qualified welding personnel identified as 052493, 0540363, Perform Shielded Metal Arc Welding (SMAW) on OBG Bike path Path side plate to deck plate joint. Joint identified as BK008A1-001-043. ZPMC CWI Identified as Guo Yan Fei with temporary welding repair report. The welding parameters as measured using QC's calibrated instrument appeared to be in general compliance with WPS-345-SMAW-2G (2F) Repair. For more information see attached picture number 1.

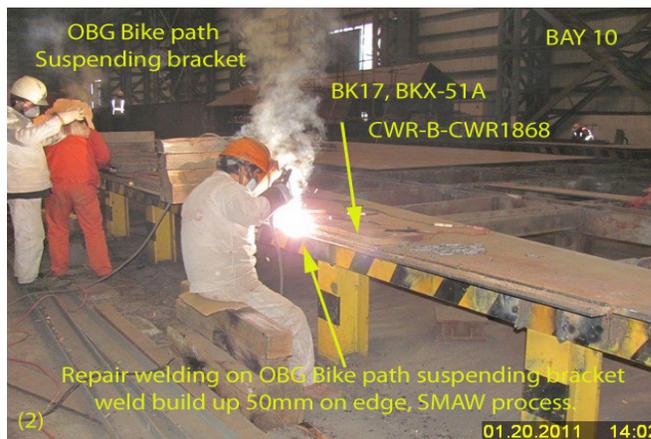
This QA Inspector observed ZPMC qualified welding personnel identified as 040582, 050038, 040270, Perform Shielded Metal Arc Welding (SMAW) on OBG Bike path suspending bracket edge plate. Plate identified as BKX51A weld build up 50mm. ZPMC QC Identified as Li Peng Fei with critical welding repair report CWR-B-CWR1868. The welding parameters as measured using QC's calibrated instrument appeared to be in general compliance with WPS-345-SMAW-2G (2F) Repair. For more information see attached picture number 2.
