**DEPARTMENT OF TRANSPORTATION**

Contract #: 04-0120F4Cty: SF/ALA Rte: 80 PM: 13.2/13.9File #: 69.28**WELDING INSPECTION REPORT****Resident Engineer:** Siegenthaler, Peter**Address:** 333 Burma Road**City:** Oakland, CA 94607**Report No:** WIR-019700**Date Inspected:** 25-Jan-2011**Project Name:** SAS Superstructure**OSM Arrival Time:** 700**Prime Contractor:** American Bridge/Fluor Enterprises, a JV**OSM Departure Time:** 1900**Contractor:** Zhenhua Port Machinery Company, Ltd (ZPMC), Changxing Island **Location:** Shanghai, China**CWI Name:** Mr. Xu Le Feng.**CWI Present:** Yes No**Inspected CWI report:** Yes No N/A**Rod Oven in Use:** Yes No N/A**Electrode to specification:** Yes No N/A**Weld Procedures Followed:** Yes No N/A**Qualified Welders:** Yes No N/A**Verified Joint Fit-up:** Yes No N/A**Approved Drawings:** Yes No N/A**Approved WPS:** Yes No N/A**Delayed / Cancelled:** Yes No N/A**Bridge No:** 34-0006**Component:** Tower and Orthotropic Box Girder (OBG)**Summary of Items Observed:**

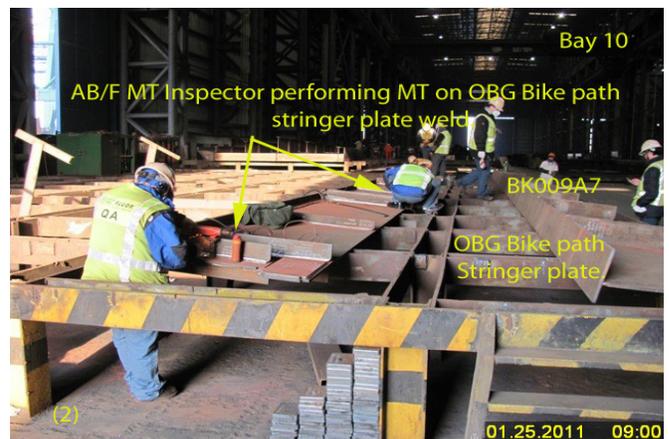
This QA Inspector observed AB/F Magnetic Particle Testing Inspector, performing MT on OBG Bike path Stringer plate. Joint identified as BK009A7-001-015, 016, 022, 148. For more information see attached picture number 2.
