DEPARTMENT OF TRANSPORTATION

Quality Assurance and Source Inspection

Contract #: 04-0120F4Cty: SF/ALA Rte: 80 PM: 13.2/13.9File #: 69.28**WELDING INSPECTION REPORT****Resident Engineer:** Siegenthaler, Peter**Address:** 333 Burma Road**City:** Oakland, CA 94607**Report No:** WIR-019705**Date Inspected:** 07-Jan-2011**Project Name:** SAS Superstructure**OSM Arrival Time:** 700**Prime Contractor:** American Bridge/Fluor Enterprises, a JV**OSM Departure Time:** 1900**Contractor:** Zhenhua Port Machinery Company, Ltd (ZPMC), Changxing Island **Location:** Shanghai, China

Bridge No: 34-0006**Component:** TOWER & OBG Components**Summary of Items Observed:**

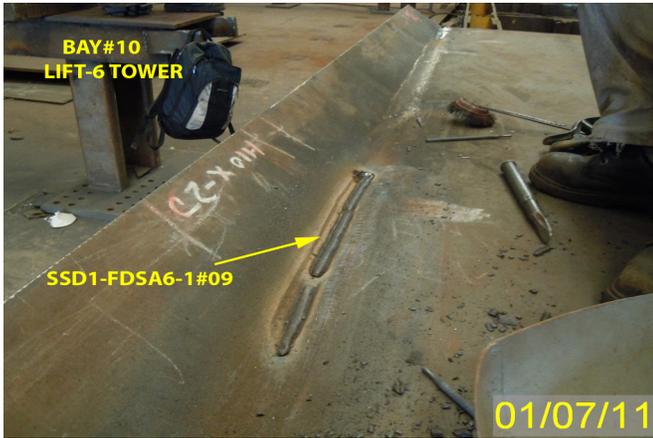
Repair welding of a weld joint # 09 located on Lift-6, Tower head component SSD1-FDSA6-1. Welder is identified as 500363. ZPMC Quality Control (QC) Inspector is identified as Li peng Fei. The welding variables recorded by QC appeared to comply with the WPS – 345 – SMAW – 1G (1F) – ESAB – Repair.
(See attached photo)
