Contract #: 04-0120F4Cty: SF/ALA Rte: 80 PM: 13.2/13.9File #: 69.28**WELDING INSPECTION REPORT****Resident Engineer:** Siegenthaler, Peter**Address:** 333 Burma Road**City:** Oakland, CA 94607**Report No:** WIR-019734**Date Inspected:** 14-Jan-2011**Project Name:** SAS Superstructure**OSM Arrival Time:** 700**Prime Contractor:** American Bridge/Fluor Enterprises, a JV**OSM Departure Time:** 1900**Contractor:** Zhenhua Port Machinery Company, Ltd (ZPMC), Changxing Island **Location:** Shanghai, China**CWI Name:** Qiu Wen.**CWI Present:** Yes No**Inspected CWI report:** Yes No N/A**Rod Oven in Use:** Yes No N/A**Electrode to specification:** Yes No N/A**Weld Procedures Followed:** Yes No N/A**Qualified Welders:** Yes No N/A**Verified Joint Fit-up:** Yes No N/A**Approved Drawings:** Yes No N/A**Approved WPS:** Yes No N/A**Delayed / Cancelled:** Yes No N/A**Bridge No:** 34-0006**Component:** OBG components.**Summary of Items Observed:**

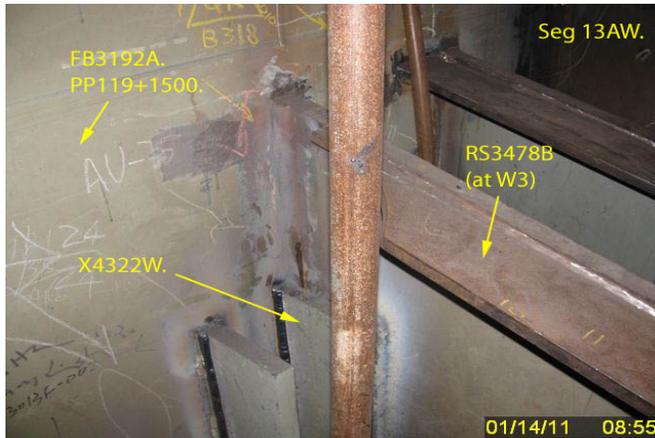
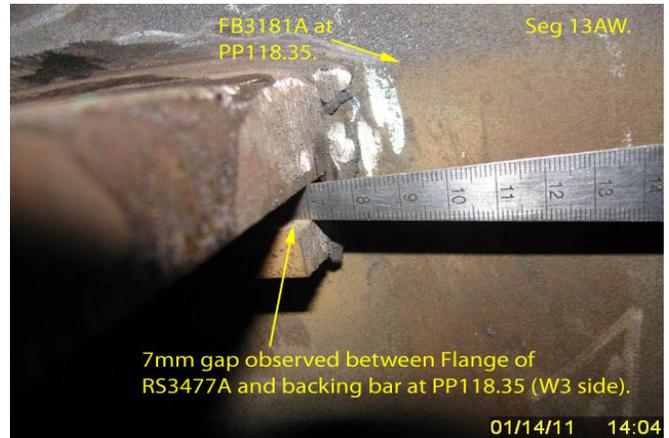
2) At PP118.35 (W3 side), FB3181A to Flange of RS3477A, CJP weld, the gap between backing bar and RS flange was observed as 7mm. Welding of this joint is completed (as per weld details, backing bar to remain in place after welding). See attached photos for further information.

NDT of the above mentioned two welds is to be done. This is also informed to CT Lead QA Inspector.
