**DEPARTMENT OF TRANSPORTATION**

Contract #: 04-0120F4Cty: SF/ALA Rte: 80 PM: 13.2/13.9File #: 69.28**WELDING INSPECTION REPORT****Resident Engineer:** Siegenthaler, Peter**Address:** 333 Burma Road**City:** Oakland, CA 94607**Report No:** WIR-019742**Date Inspected:** 05-Dec-2010**Project Name:** SAS Superstructure**OSM Arrival Time:** 700**Prime Contractor:** American Bridge/Fluor Enterprises, a JV**OSM Departure Time:** 1900**Contractor:** Zhenhua Port Machinery Company, Ltd (ZPMC), Changxing Island **Location:** Shanghai, China**CWI Name:** Qiu Wen**CWI Present:** Yes No**Inspected CWI report:** Yes No N/A**Rod Oven in Use:** Yes No N/A**Electrode to specification:** Yes No N/A**Weld Procedures Followed:** Yes No N/A**Qualified Welders:** Yes No N/A**Verified Joint Fit-up:** Yes No N/A**Approved Drawings:** Yes No N/A**Approved WPS:** Yes No N/A**Delayed / Cancelled:** Yes No N/A**Bridge No:** 34-0006**Component:** OBG**Summary of Items Observed:**

## WELDING INSPECTION REPORT

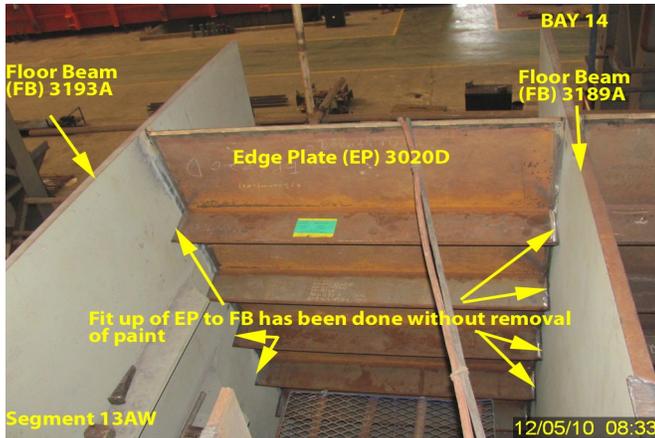
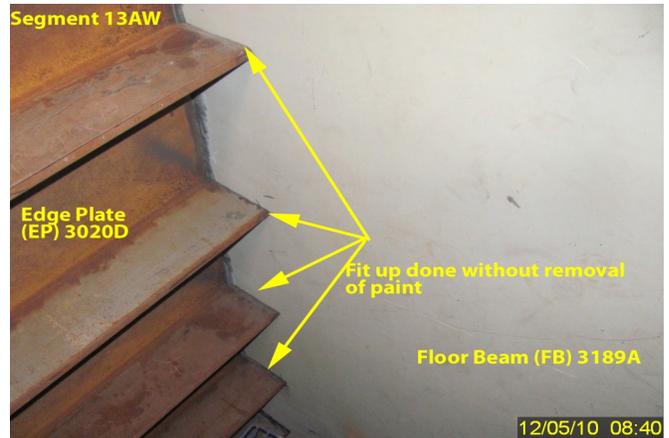
During random in process inspection this QA inspector observed that fit up of Edge Plate (EP) 3020D to Floor Beam (FB) 3193A and FB 3189A, EP 3020C to FB 3189A and FB 3186A, EP 3020B to FB 3186A has been done by ZPMC personnel. The paint was not removed on the contact area of stiffener of edge plate to floor beam connection area.

This issue has been discussed with ZPMC CWI Mr. Qiu Wen and CT lead QA. Mr Qiu Wen informed this QA that ZPMC will not proceed for welding without removal of paint. Attached photograph provide additional details.
