DEPARTMENT OF TRANSPORTATION

Quality Assurance and Source Inspection

WELDING INSPECTION REPORT

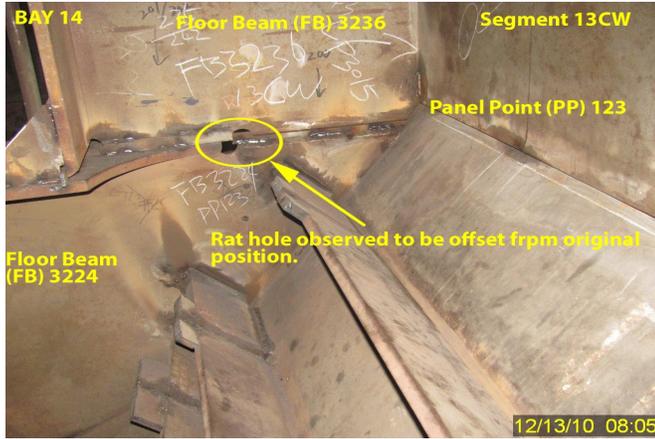
During random in process inspection this QA inspector observed that fit up of Floor Beam (FB) 3236A to Floor Beam (FB) 3224A at Panel Point (PP) 123 of segment 13CW has been done. The rat hole was observed to be offset from original position. Additional photograph provide additional detail.
