DEPARTMENT OF TRANSPORTATION

Contract #: 04-0120F4Cty: SF/ALA Rte: 80 PM: 13.2/13.9File #: 1.28**WELDING INSPECTION REPORT****Resident Engineer:** Siegenthaler, Peter**Address:** 333 Burma Road**City:** Oakland, CA 94607**Report No:** WIR-019815**Date Inspected:** 31-Jan-2011**Project Name:** SAS Superstructure**OSM Arrival Time:** 1000**Prime Contractor:** American Bridge/Fluor Enterprises, a JV**OSM Departure Time:** 1830**Contractor:** American Bridge/Fluor Enterprises, a JV**Location:** Job Site**CWI Name:** Gary Ersham**CWI Present:** Yes No**Inspected CWI report:** Yes No N/A**Rod Oven in Use:** Yes No N/A**Electrode to specification:** Yes No N/A**Weld Procedures Followed:** Yes No N/A**Qualified Welders:** Yes No N/A**Verified Joint Fit-up:** Yes No N/A**Approved Drawings:** Yes No N/A**Approved WPS:** Yes No N/A**Delayed / Cancelled:** Yes No N/A**Bridge No:** 34-0006**Component:** Orthotropic Box Girder**Summary of Items Observed:**

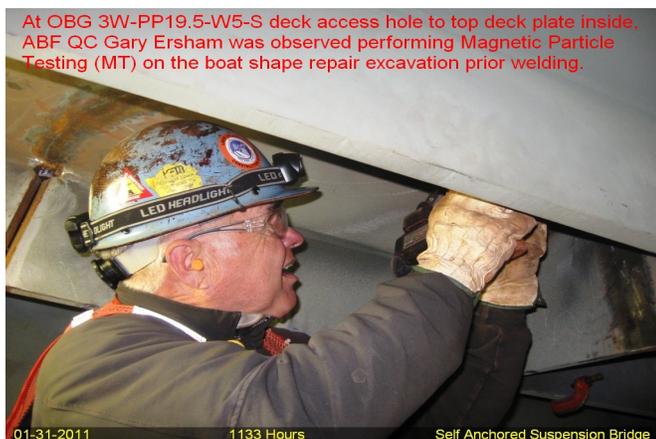
At OBG 3W-PP19.5-W5-S deck access hole to top deck plate inside, QA randomly observed ABF/JV qualified welder Wai Kitlai perform CJP repair welding. The welder was noted welding in 4G (overhead) position utilizing SMAW with 1/8" diameter E7018H4R electrode implementing Caltrans approved Welding Procedure Specification (WPS) ABF-WPS-D15-1001 Repairs. The welding repairs were excavated to a boat shape profile and were tested with MT prior welding. During welding, ABF QC Gary Ersham was noted monitoring the welder and his welding parameters. QA noted parameter during welding was 135 amperes which appears in compliance to the WPS. The locations of the repairs were noted below;

Location	Y-dimension	Length	Width	Depth	Remarks
1.	220mm	120mm	25mm	7mm	Completed
2.	460mm	100mm	25mm	8mm	Completed
3.	1950mm	100mm	25mm	8mm	Completed
4.	3185mm	100mm	24mm	6mm	Completed
5.	3415mm	120mm	25mm	11mm	Completed
