Contract #: 04-0120F4Cty: SF/ALA Rte: 80 PM: 13.2/13.9File #: 69.28**WELDING INSPECTION REPORT****Resident Engineer:** Siegenthaler, Peter**Address:** 333 Burma Road**City:** Oakland, CA 94607**Report No:** WIR-019834**Date Inspected:** 08-Jan-2011**Project Name:** SAS Superstructure**OSM Arrival Time:** 1500**Prime Contractor:** American Bridge/Fluor Enterprises, a JV**OSM Departure Time:** 300**Contractor:** Zhenhua Port Machinery Company, Ltd (ZPMC), Changxing Island **Location:** Shanghai, China**CWI Name:** Mr. Yu Jiao (ABF)**CWI Present:** Yes No**Inspected CWI report:** Yes No N/A**Rod Oven in Use:** Yes No N/A**Electrode to specification:** Yes No N/A**Weld Procedures Followed:** Yes No N/A**Qualified Welders:** Yes No N/A**Verified Joint Fit-up:** Yes No N/A**Approved Drawings:** Yes No N/A**Approved WPS:** Yes No N/A**Delayed / Cancelled:** Yes No N/A**Bridge No:** 34-0006**Component:** BAY 14 OBG**Summary of Items Observed:**

OBG BAY 14

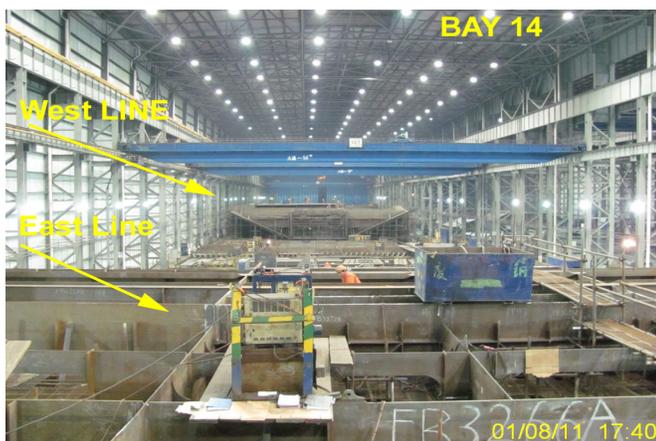
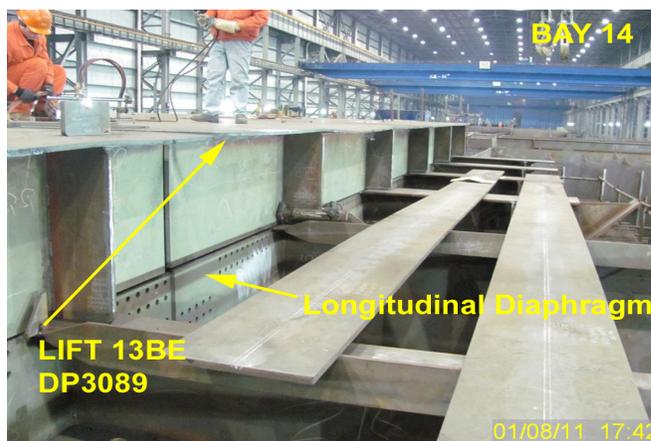
SMAW welding of complete joint penetration weld joint(s) located on lift 13A East Line SEG3007Q Floor Beam to Floor Beam weld number(s) 310. Welder is identified as welder no. 066416. The welding variables recorded by ZPMC QC identified as Zong Guo Hui appeared to comply with applicable WPS(s) WPS-B-P-2211-TC-U4b-FCM-1.

SMAW welding of fillet weld joint(s) located on lift 13C East Line DP3109A Deck Plate to Diaphragm Beam weld number(s) 112, 091, and 097. Welder is identified as welder no. 066478. The welding variables recorded by ZPMC QC identified as Zong Guo Hui appeared to comply with applicable WPS(s) WPS-B-P-2212-TC-U4b-FCM-1 and WPS(s) WPS-B-P-2213-TC-U4b-FCM-1.

SMAW welding of fillet weld joint(s) located on lift 13C East Line DP3108A Deck Plate to Diaphragm Beam weld number(s) 068, 067, 137, and 088. Welder is identified as welder no. 008087. The welding variables recorded by ZPMC QC identified as Zong Guo Hui appeared to comply with applicable WPS(s)

FCAW welding of complete joint penetration weld joint(s) located on lift 13A East Line SEG3007M Floor Beam to Bottom Plate weld number(s) 251. Welder is identified as welder no. 066283. The welding variables recorded by ZPMC QC identified as Zong Guo Hui appeared to comply with applicable WPS(s) WPS-B-T-2232-ESAB.

FCAW welding of complete joint penetration weld joint(s) located on lift 13A East Line SEG3007D Floor Beam to Bottom Plate weld number(s) 197 and 196. Welder is identified as welder no. 067947. The welding variables recorded by ZPMC QC identified as Zong Guo Hui appeared to comply with applicable WPS(s) WPS-B-T-2232-ESAB.

ZPMC personnel heat straightening Orthotropic Box Girder (OBG) member identified as Lift 13 DP3091A-001, weld joint(s) 018, 021, 024, 027, and 030. Distortion appeared to be caused by welding of the material. ZPMC Quality Control (QC) inspector identified as Mr. Li Ping was present to monitor the heat straightening process. The heat straightening appeared to comply with Heat Straightening Report HSR-9984.
