**DEPARTMENT OF TRANSPORTATION**

Contract #: 04-0120F4Cty: SF/ALA Rte: 80 PM: 13.2/13.9File #: 74.28**WELDING INSPECTION REPORT****Resident Engineer:** Siegenthaler, Peter**Address:** 333 Burma Road**City:** Oakland, CA 94607**Report No:** WIR-019843**Date Inspected:** 19-Jan-2011**Project Name:** SAS Superstructure**OSM Arrival Time:** 900**Prime Contractor:** American Bridge/Fluor Enterprises, a JV**OSM Departure Time:** 1800**Contractor:** Goodwin Steel, UK**Location:** Trentham, UK

# WELDING INSPECTION REPORT

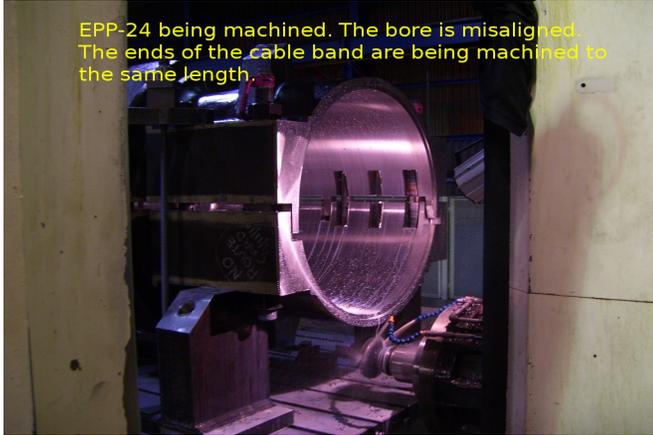
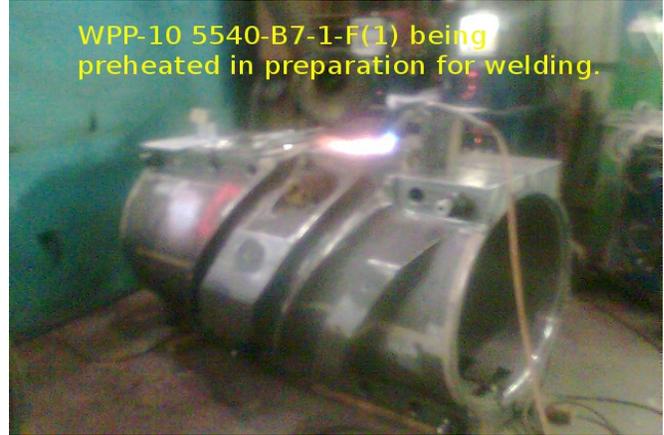
The QA Inspector did periodically observe the in process machining of an assembled B8 Type 1 cable band, castings GG29432-8, 5540-B8-1-M and GG29433-1, 5540-B8-1-F for West Panel Point 22. The rope grooves are being machined to restore alignment following welding. Goodwin International personnel were performing the machining.

The QA Inspector did periodically observe the in process machining of an assembled B8 Type 1 cable band, castings GG29432-4, 5540-B8-1-M and GG29433-9, 5540-B8-1-F for East Panel Point 24. The end is being machined to achieve equal lengths of the castings. Goodwin International personnel were performing the machining.
