DEPARTMENT OF TRANSPORTATION

Contract #: 04-0120F4Cty: SF/ALA Rte: 80 PM: 13.2/13.9File #: 1.28**WELDING INSPECTION REPORT****Resident Engineer:** Siegenthaler, Peter**Address:** 333 Burma Road**City:** Oakland, CA 94607**Report No:** WIR-019854**Date Inspected:** 01-Feb-2011**Project Name:** SAS Superstructure**OSM Arrival Time:** 630**Prime Contractor:** American Bridge/Fluor Enterprises, a JV**OSM Departure Time:** 1500**Contractor:** American Bridge/Fluor Enterprises, a JV**Location:** Job Site**CWI Name:** See Below**CWI Present:** Yes No**Inspected CWI report:** Yes No N/A**Rod Oven in Use:** Yes No N/A**Electrode to specification:** Yes No N/A**Weld Procedures Followed:** Yes No N/A**Qualified Welders:** Yes No N/A**Verified Joint Fit-up:** Yes No N/A**Approved Drawings:** Yes No N/A**Approved WPS:** Yes No N/A**Delayed / Cancelled:** Yes No N/A**Bridge No:** 34-0006**Component:** Orthotropic Box Girders**Summary of Items Observed:**

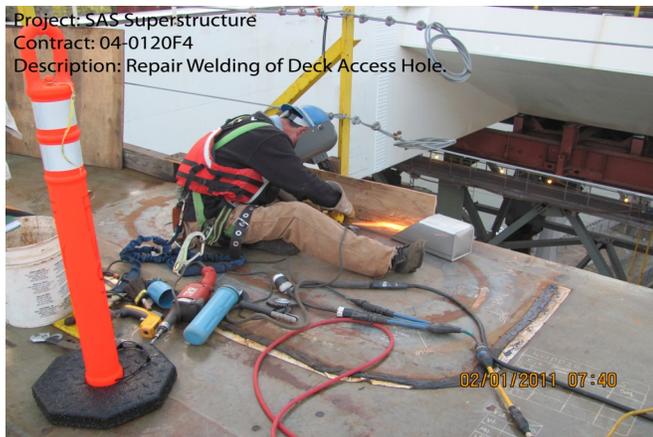
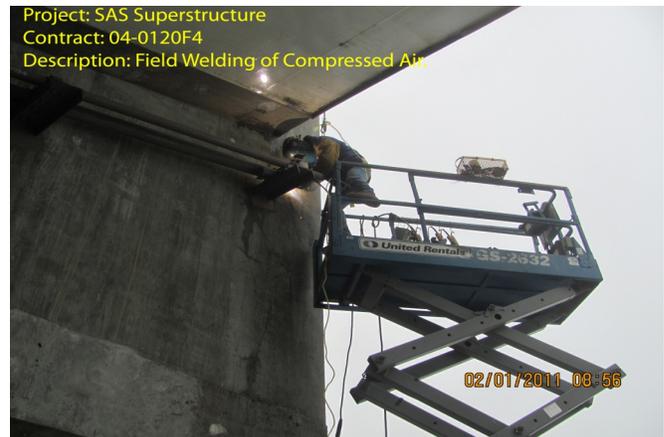
The digital photographs below illustrate some of the work observed during this scheduled shift.
