Contract #: 04-0120F4Cty: SF/ALA Rte: 80 PM: 13.2/13.9File #: 69.28**WELDING INSPECTION REPORT****Resident Engineer:** Siegenthaler, Peter**Address:** 333 Burma Road**City:** Oakland, CA 94607**Report No:** WIR-019864**Date Inspected:** 02-Jan-2011**Project Name:** SAS Superstructure**OSM Arrival Time:** 1900**Prime Contractor:** American Bridge/Fluor Enterprises, a JV**OSM Departure Time:** 700**Contractor:** Zhenhua Port Machinery Company, Ltd (ZPMC), Changxing Island **Location:** Shanghai, China**CWI Name:** See Below**CWI Present:** Yes No**Inspected CWI report:** Yes No N/A**Rod Oven in Use:** Yes No N/A**Electrode to specification:** Yes No N/A**Weld Procedures Followed:** Yes No N/A**Qualified Welders:** Yes No N/A**Verified Joint Fit-up:** Yes No N/A**Approved Drawings:** Yes No N/A**Approved WPS:** Yes No N/A**Delayed / Cancelled:** Yes No N/A**Bridge No:** 34-0006**Component:** OBG**Summary of Items Observed:**

OBG Bay 14

Segment 13 West

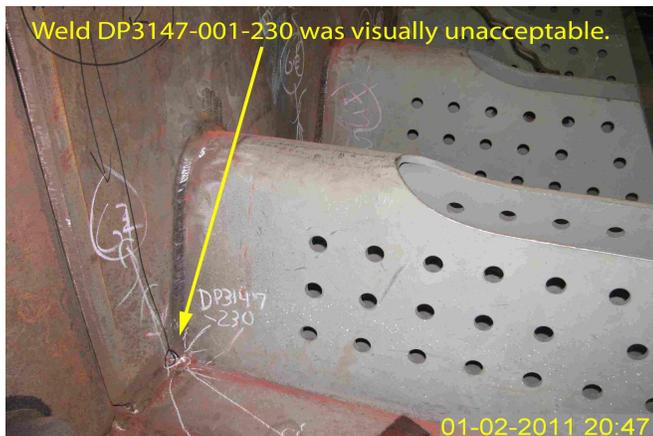
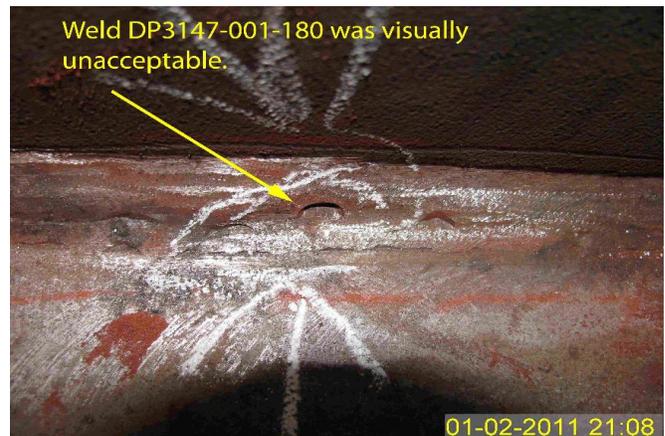
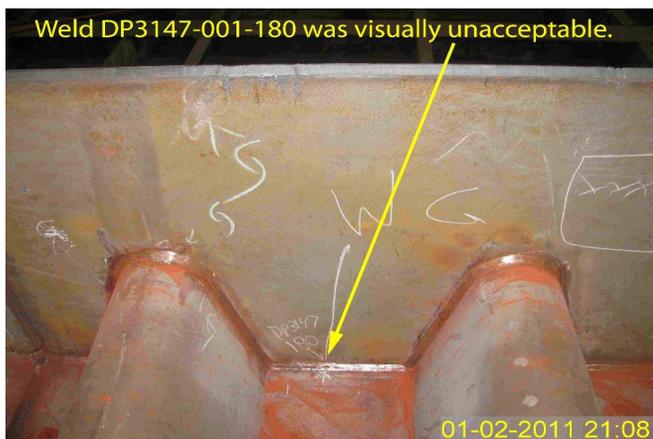
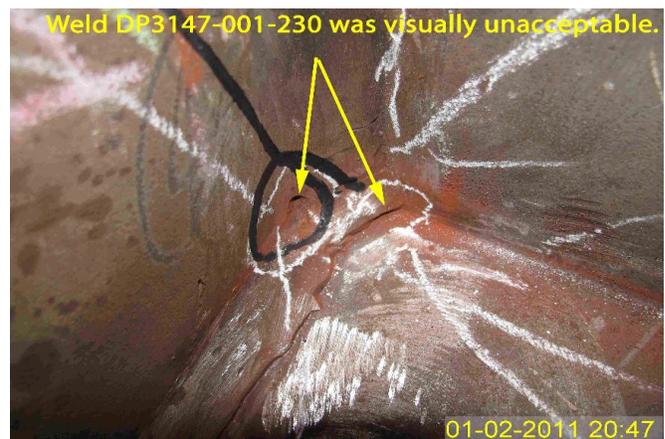
Other Caltrans QA Inspectors performed MT inspections of similar welds on these and other deck plates. This QA Inspector observed welds DP3147-001-180, DP3147-001-230 and DP3147-131 were visually rejectable due to weld overlap and underfill. This QA Inspector showed these three visually unacceptable welds to ABF CWI Mr. Yu Jiao and he marked these areas as requiring weld repairs. Approximately eight other welds had overlap and ZPMC workers performed grinding of these areas. Following welding and grinding of various welds, items observed by this QA Inspector appeared to comply with AWS D1.5 MT and VT requirements. For additional information on these inspections see this QA Inspector's TL6028 Magnetic Particle Test Report and the photographs below.

This QA Inspector observed ZPMC welder Mr. Wang Zhengbin, stencil 216086 used shielded metal arc welding procedures WPS-345-SMAW-2G(2F)-FCM-Repair-1 and WPS-345-SMAW-3G(3F)-FCM-Repair-1 to repair of visual rejections in welds DP3147-001-180, DP3147-001-230 and DP3147-001-131. This QA Inspector measured a welding current of approximately 225 amps. The base materials had been preheated with an acetylene torch and Mr. Wang Zhengbin appeared to be certified to make this weld. Items observed on this date appeared to generally comply with applicable contract documents.
