DEPARTMENT OF TRANSPORTATION

Contract #: 04-0120F4Cty: SF/ALA Rte: 80 PM: 13.2/13.9File #: 69.28**WELDING INSPECTION REPORT****Resident Engineer:** Pursell, Gary**Address:** 333 Burma Road**City:** Oakland, CA 94607**Report No:** WIR-020041**Date Inspected:** 08-Apr-2010**Project Name:** SAS Superstructure**OSM Arrival Time:** 645**Prime Contractor:** American Bridge/Fluor Enterprises, a JV**OSM Departure Time:** 1845**Contractor:** Zhenhua Port Machinery Company, Ltd (ZPMC), Changxing Island **Location:** Shanghai, China

CWI Name:	Liu Hua Jie, Lu Li Qing, Geng W			CWI Present:	Yes	No	
Inspected CWI report:	Yes	No	N/A	Rod Oven in Use:	Yes	No	N/A
Electrode to specification:	Yes	No	N/A	Weld Procedures Followed:	Yes	No	N/A
Qualified Welders:	Yes	No	N/A	Verified Joint Fit-up:	Yes	No	N/A
Approved Drawings:	Yes	No	N/A	Approved WPS:	Yes	No	N/A
				Delayed / Cancelled:	Yes	No	N/A
Bridge No:	34-0006			Component:	Orthotropic Box Girder (OBG)

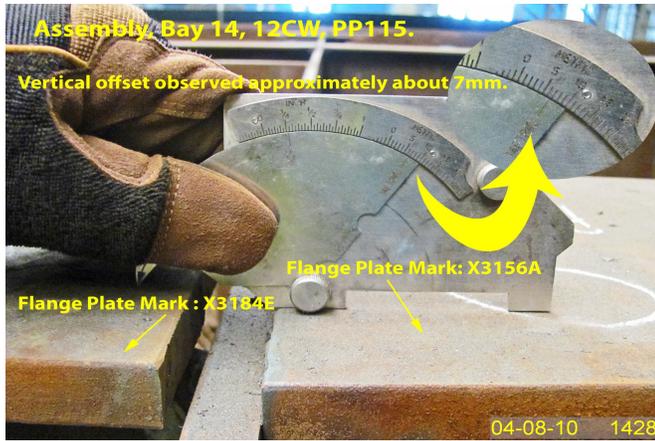
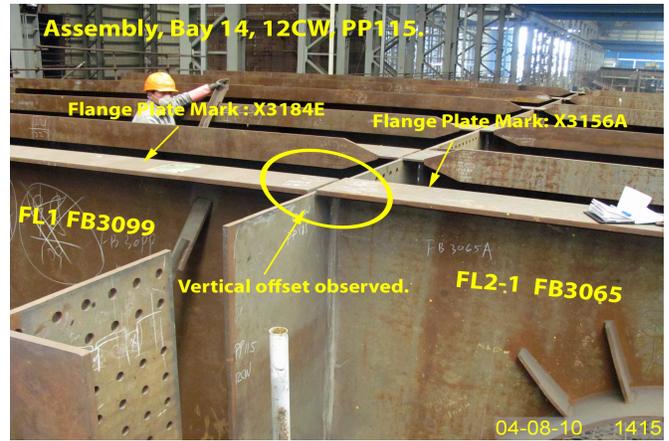
- At PP115, offset observed approximately about 7mm, between FL1-Floor beam 3099 (Plate mark-flange: X3184E) & FL2-1-Floor beam 3065A (Plate mark-flange: X3156A). (Vertical offset as shown in photographs).
- Welding has been completed on FL1 to Side panel & FL2-1 to LD.

This QA inspector have submitted Incident report for this issue on this date. The attached photographs provide additional detail.
