DEPARTMENT OF TRANSPORTATION

Contract #: 04-0120F4Cty: SF/ALA Rte: 80 PM: 13.2/13.9File #: 99.28**WELDING INSPECTION REPORT****Resident Engineer:** Siegenthaler, Peter**Address:** 333 Burma Road**City:** Oakland, CA 94607**Report No:** WIR-020077**Date Inspected:** 24-Jan-2011**Project Name:** SAS Superstructure**OSM Arrival Time:** 700**Prime Contractor:** American Bridge/Fluor Enterprises, a JV**OSM Departure Time:** 1900**Contractor:** Zhenhua Port Machinery Company, Ltd (ZPMC) Chanxing Island**Location:** Shanghai, China

| Bridge No: | 34-0006 | Component: | OBG Segment | |

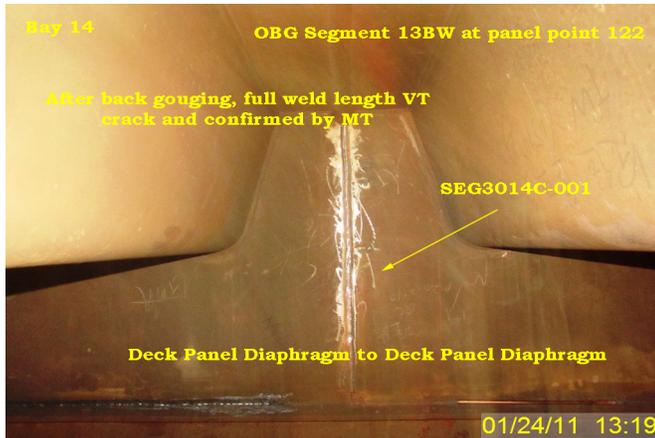
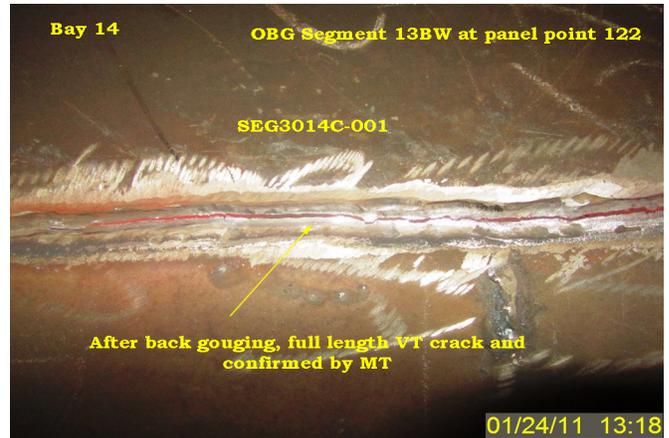
Description of Incident: During the Quality Assurance random visual inspection of welds located on Segment 13BW at panel point 122, this Quality Assurance Inspector (QA) observed that ZMPC personnel performed welding on Deck Panel Diaphragm to deck panel diaphragm weld, after back gouging of these welds are get cracks throughout weld length. It happens also at pp121.5 and 122 cross beam side Deck Panel Diaphragm to deck panel diaphragm welds of OBG Segment 13CW. This weld is a Complete Joint Penetration (CJP) weld joining the Deck Panel Diaphragm to deck panel diaphragm weld. The Deck Panel Diaphragm to deck panel diaphragm weld is identified as SPCM. The weld numbers are identified as SEG3014C-001 and 002. This weld is designated as Seismic Performance Critical Member (SPCM). OBG segment 13BW is located West Side of Bay 14 area. The ZPMC QC is identified as Mr. Sun Tian Liang. QA inform to ZPMC that prior to the repair welding, to prepare CWR and ensure with VT and MT all defect have been removed. See the attaché picture.
